A Detailed Electronic Mechanism for Sudden Unintended Acceleration

Ronald A. Belt
Plymouth, MN 55447
2 August 2012

Abstract: An electronic cause for sudden unintended acceleration was discussed in a previous paper. The cause was attributed to a negative voltage spike on the battery supply line leading to a brownout error that causes faulty operation of the CPUs, keep-alive memory, and/or EEPROM memory, resulting in a data error that causes unpredictable engine operation, such as sudden acceleration. While this cause explained many observations associated with sudden acceleration, the theory was incomplete because it never identified the precise hardware or software fault producing the data error. In this paper a mechanism for this data error is presented. The mechanism involves a sudden change in the correction value that is used to adjust the PWM duty cycle applied to the throttle motor to compensate for variations in the battery voltage. The evidence for and against this mechanism is discussed.

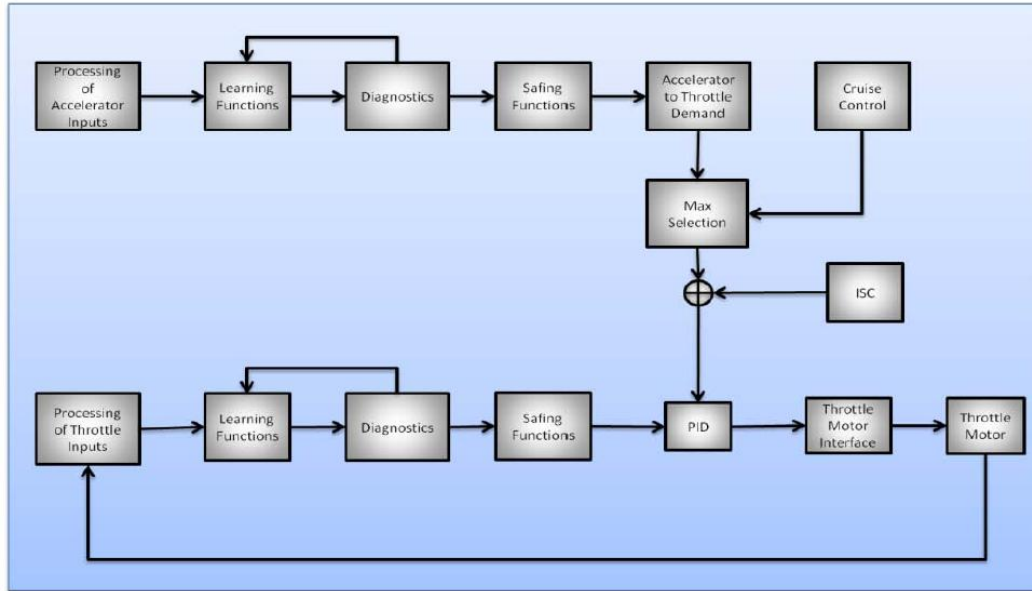
Observation 2) implies that the root cause lies somewhere within the functional diagram of an electronic throttle system as shown in Figure 1. NASA studied all the functions in this diagram for Toyota's ETCS-i system and

Fig 1. Electronic throttle system functional diagram taken from the NASA final report³

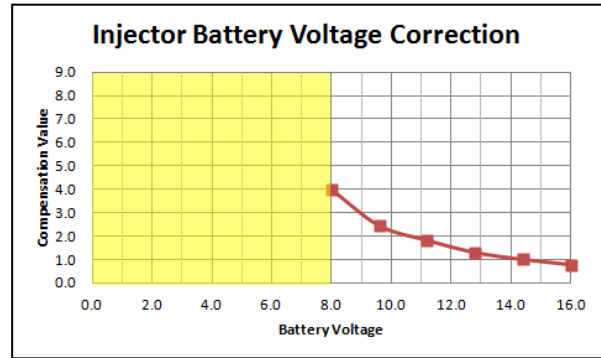
Fig 5. Injector dead time for a Buick Regal obtained via look-up table (normalized to 1 for 14.4V)

Incidentally, a similar battery voltage correction is made to the injector “on” times, which control the amount of fuel squirted into the cylinders during each combustion cycle. This is because the fuel pressure and the time it takes before an injector opens also depend on the battery voltage, and also are reduced as the battery voltage is lowered. However, in this case the battery voltage correction is an additive value which is added to the injector “on” time. This value is shown in Figure 5. It does not have a simple dependence on battery voltage, so it is usually measured and then put into a look-up table from which it is obtained by the CPU during engine operation.
