Sudden Unintended Acceleration in an All-Electric Vehicle

Ronald A. Belt
Plymouth, MN 55447
27 February 2015

Abstract: Six sudden unintended acceleration incidents have been reported with Tesla's Model S all-electric vehicle following its introduction in 2012. The cause of these incidents is explained by a runaway condition in the traction motor controller that is precipitated by a negative voltage spike on the battery supply line. This explanation is very similar to the author's explanation for a runaway condition in the electronic throttle controller of gasoline engines, which explains the cause of sudden unintended acceleration in vehicles having electronic throttles. The root cause of the problem is explained, and potential solutions are discussed.

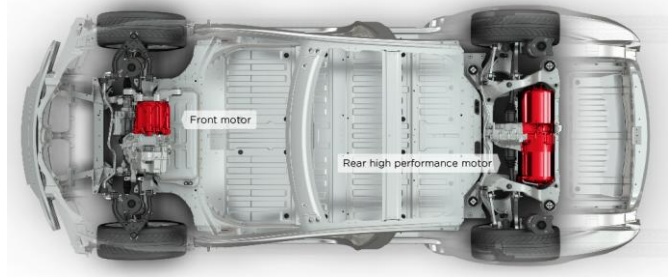
Figure 1. Traction motor locations¹⁰

Control Loop with a Map Having Speed as One Input Variable. The Tesla Model S vehicle comes in four variations, as shown in Table 1. Two of the variations have one traction motor in the rear only, while the other two variations have two traction motors, one in the front and one in the rear, as shown in Figure 1.
