**National Highway
Traffic Safety
Administration**

Subject: FINAL REPORT: "2007 Lexus ES-350 Unintended
Acceleration"

**VRTC MEMORANDUM REPORT EA07-010
VRTC-DCD-7113**

2007 Lexus ES-350 Unintended Acceleration

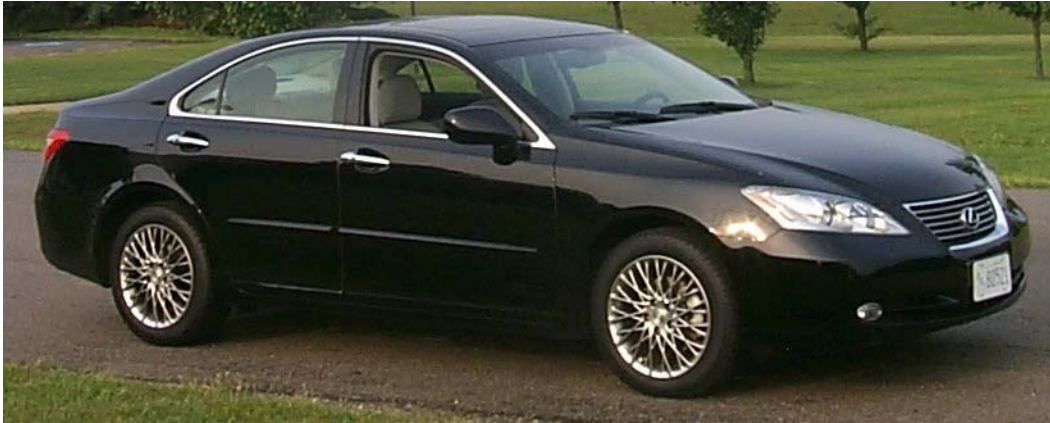
Figure 1 – 2007 Lexus ES-350

The Vehicle Research and Test Center obtained a Lexus ES-350 for testing (see Figure 1). The vehicle was fully instrumented to monitor and acquire data relating to yaw rate, speed, acceleration, deceleration, brake pedal effort, brake line hydraulic pressure, brake pad temperature, engine vacuum, brake booster vacuum, throttle plate position, and accelerator pedal position. Multiple electrical signals were introduced into the electrical system to test the robustness of the electronics against single point failures due to electrical interference. The system proved to have multiple redundancies and showed no vulnerabilities to electrical signal activities. Magnetic fields were introduced in proximity to the throttle body and accelerator pedal potentiometers and did result in an increase in engine revolutions per minute (RPM) of up to approximately 1,000 RPM, similar to a cold-idle engine RPM level. Mechanical interferences at the throttle body caused the engine to shut down. Mechanical interferences at the accelerator
