SUMMARY REPORT:
CENTRE MOUNTED TANK SYSTEM
FOR GM 1500 PICKUP TRUCKS

Prepared for: Dr. Ken Digges
Automotive Safety
Research Institute

Date: March 8, 2001

Report No.: R01-02

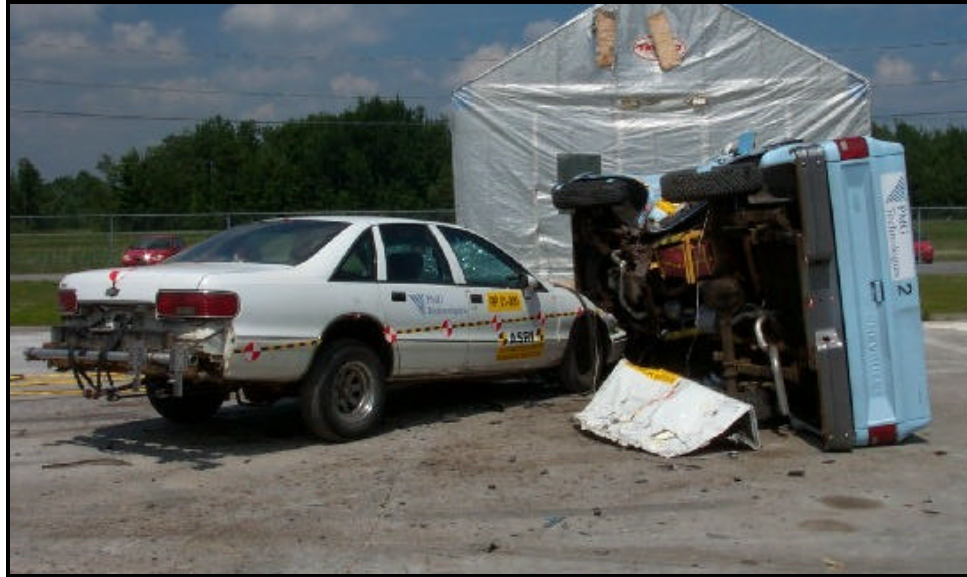
Figure 15: The final resting position of the truck and bullet vehicle in test RP 01-009.

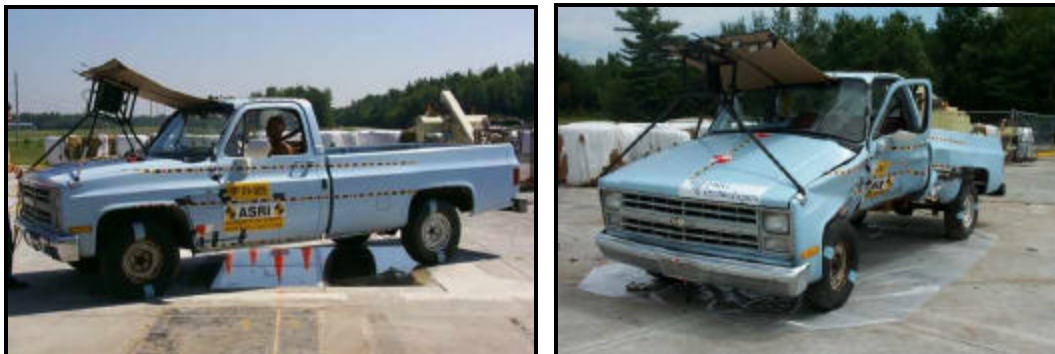
Figure 16: Pre and post test views of the GM pickup truck (test RP 01-009).

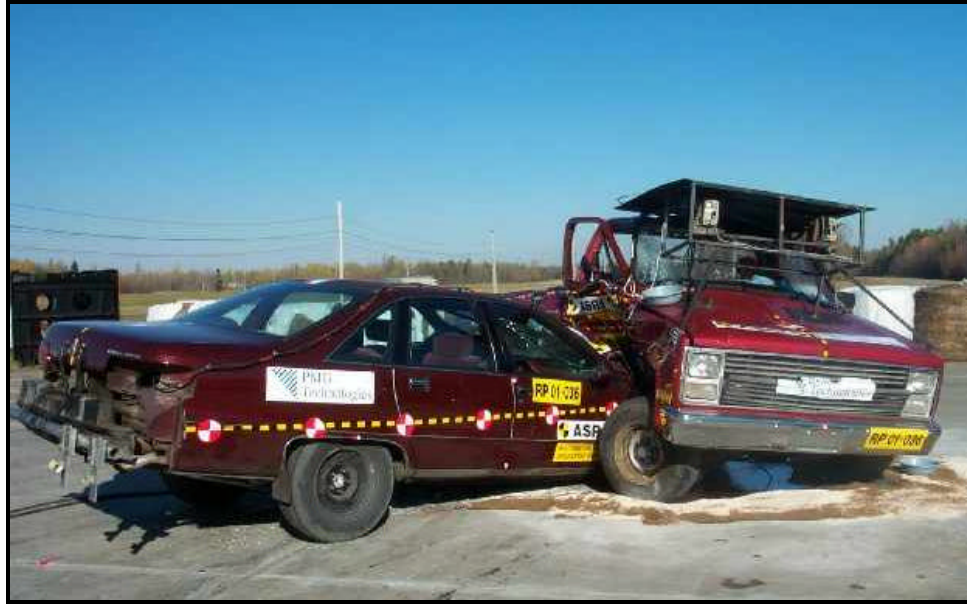
Figure 24: Final resting position of the truck and bullet vehicle in test RP 01-036.

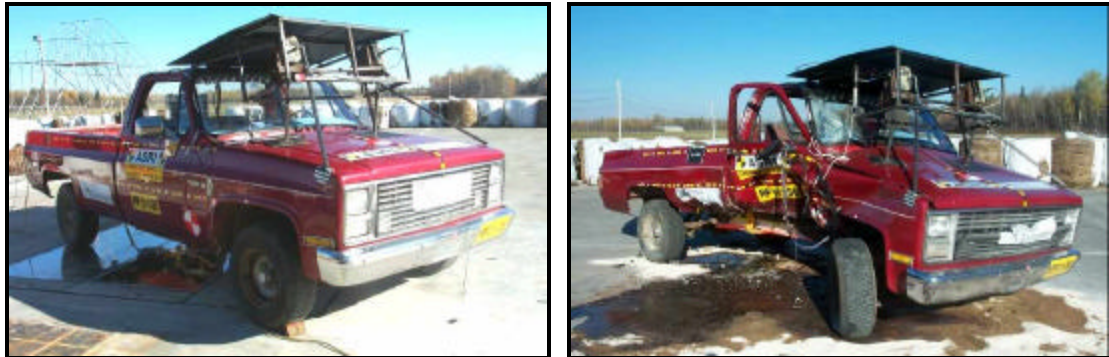
Figure 25: Pre and post test views of the GM pickup truck (test RP 01-036).

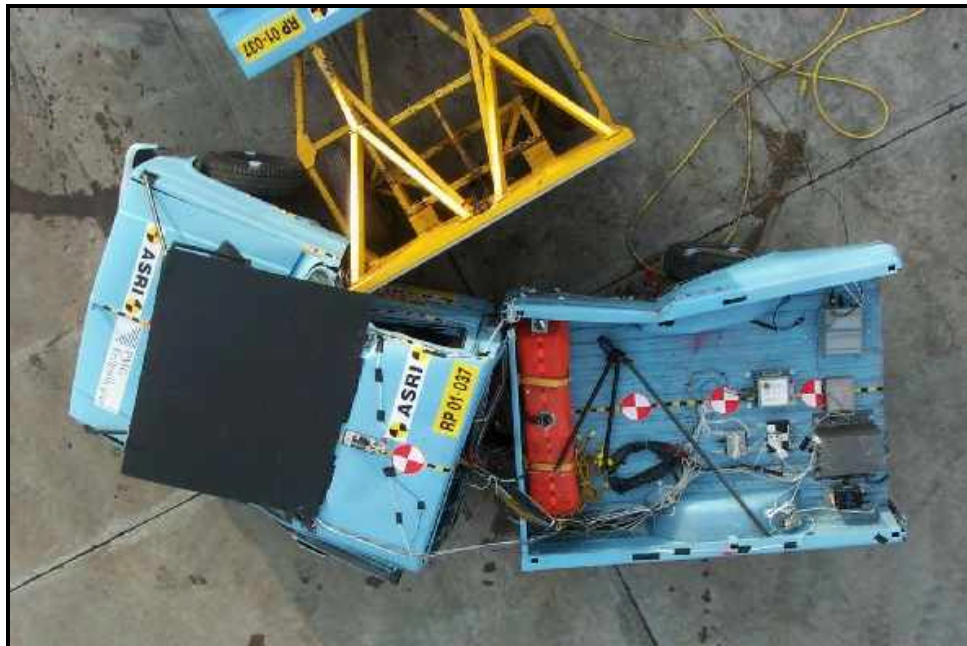
Figure 33: The final resting position of the truck and rigid barrier in test RP 01-037.

The alignment of the barrier was such that the crush zone on the truck was aft of the A-pillar and forward of the rear axle (referring back to Figure 33). By avoiding these two rigid elements of the truck, maximum loading of the tank systems was achieved.

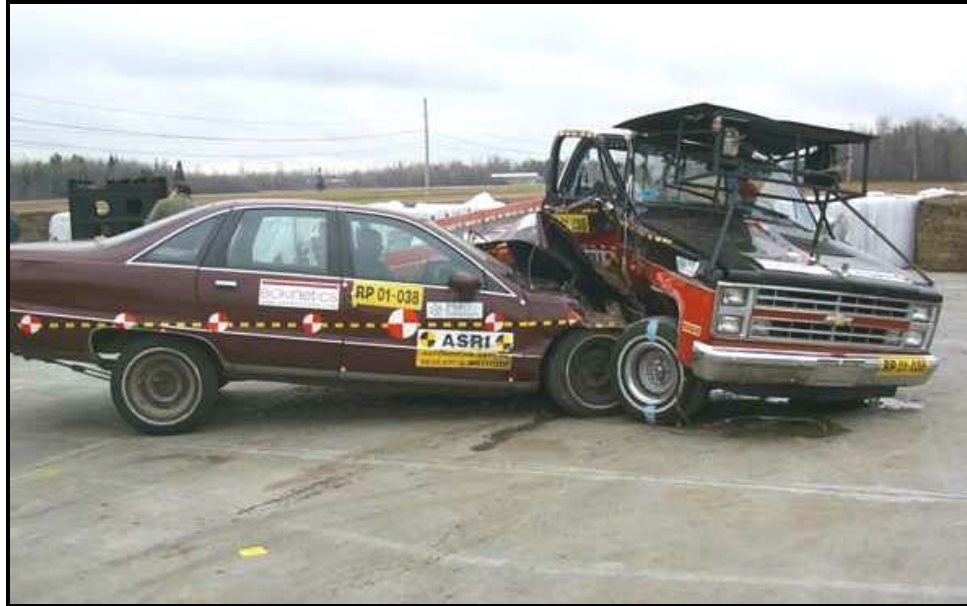
Figure 38: The final resting position of the truck and the bullet vehicle in test RP 01-038.

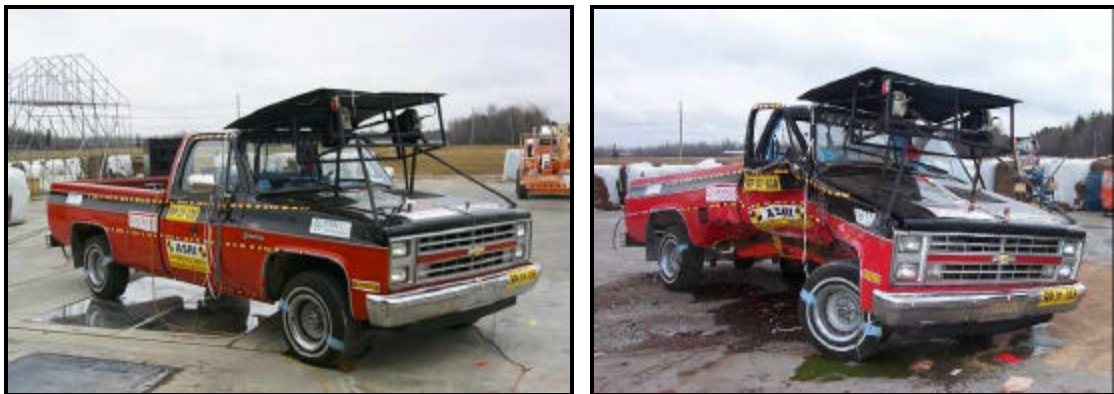
Figure 39: Pre and post test views of the GM pickup truck (test RP 01-038)

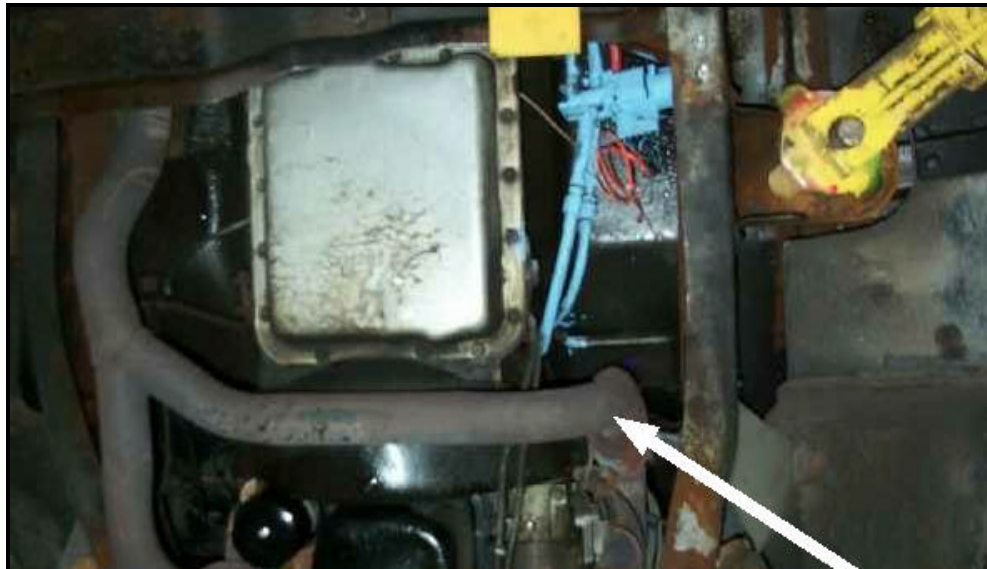
The complete exhaust system, including the manifold, was removed from the truck to achieve a target truck weight of 4400 lb. One of the tubes from the manifold normally runs down between the frame rail and the transmission and its presence may have prevented the damage to the fuel line by acting as a somewhat rigid spacer between the rail and transmission providing clearance for the fuel line. A typical manifold on the GM truck is shown in Figure 44.

Figure 44: Typical exhaust manifold on the GM pickup trucks. (Although shown in the photo there is no switching valve in the current test).

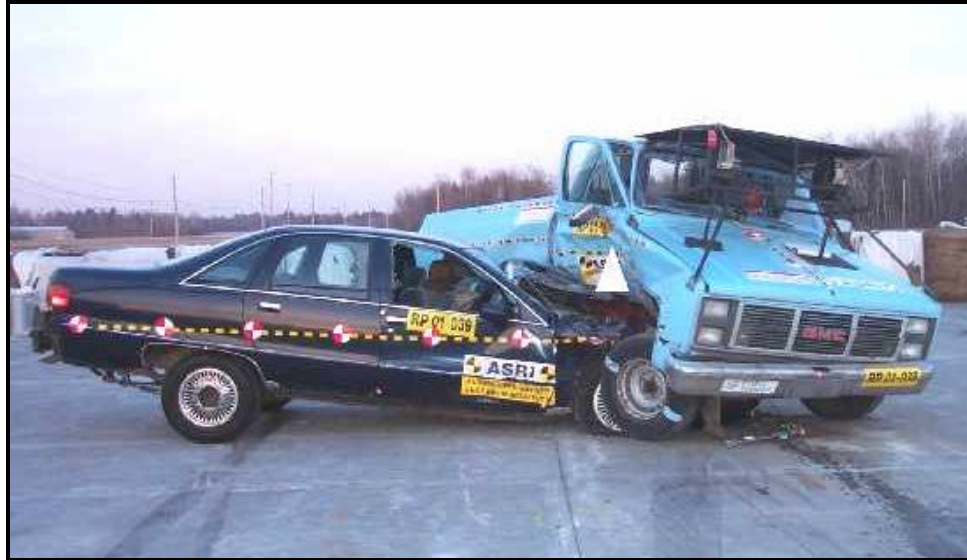
Figure 50: The final resting position of the truck and bullet vehicle in test RP 01-039.

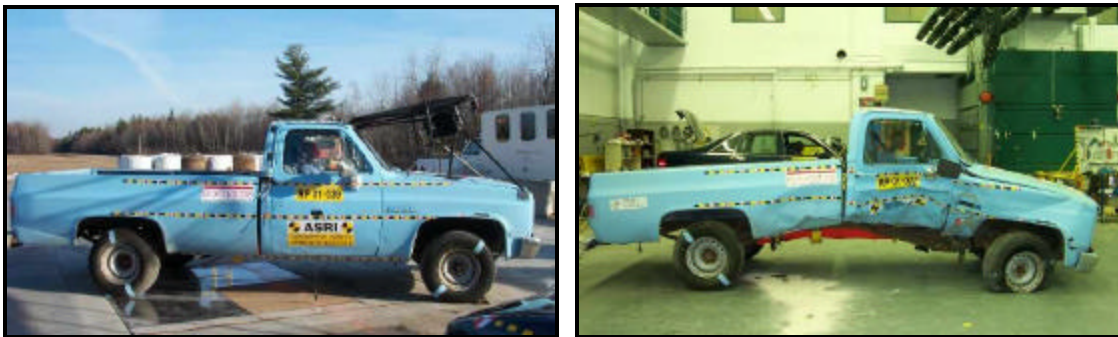
Figure 51: Pre and post test views of the GM pickup truck (test RP 01-039).

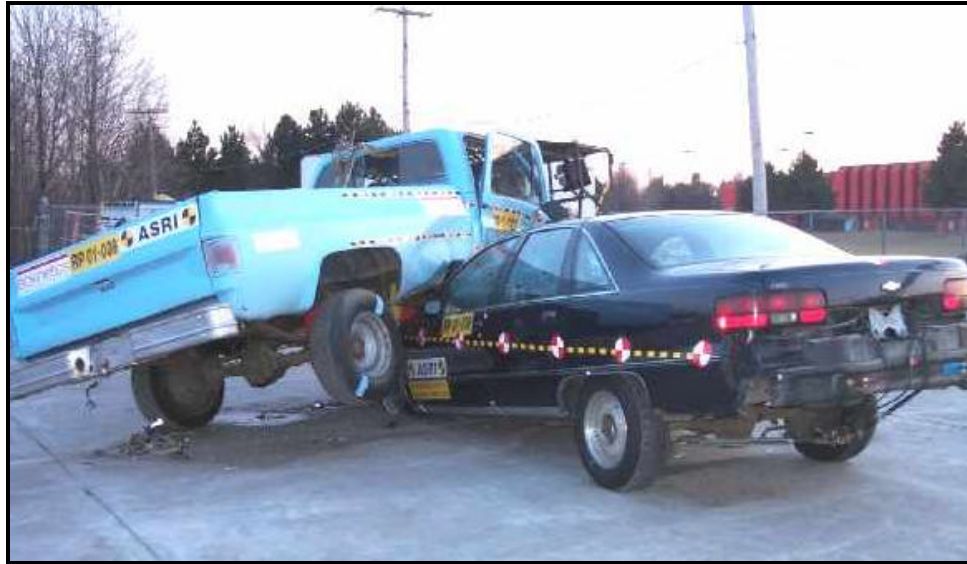
truck remained on top of the Caprice, similar to other tests. However, the right rear wheel remained noticeably higher of the ground thus more of the weight of the truck was been born by its under carriage including the centre tank (see Figure 53).

Figure 53: Post test view showing the right rear tire on the truck is noticeably off the ground (test RP 01-039).

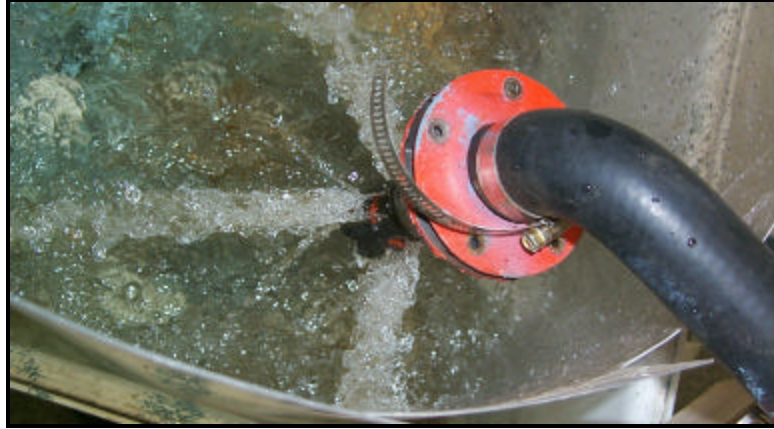
The complete fuel supply system comprised of the filler throat, the horizontal supply hose, the reducer/elbow and the check valve (see Figure 66). A detailed shot of the check valve and the reducer/elbow can be seen in Figure 67. A view of the water draining through the check valve is shown in Figure 68. The time required to drain the container was measured to be 85 seconds.

Figure 68: Water draining through the check valve.

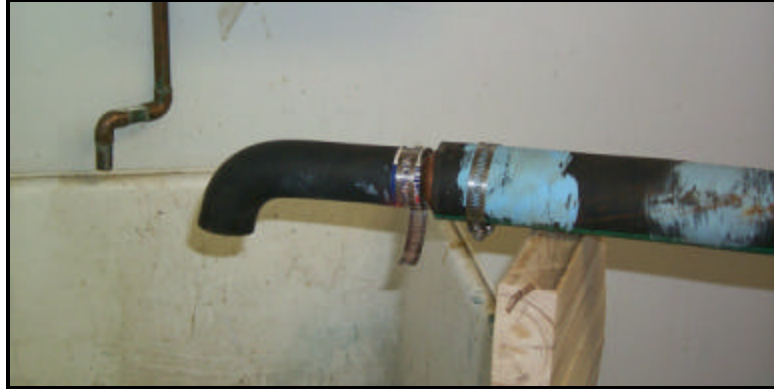
This system is identical to the one above with the exception that there is no check valve at the end of the supply system (see Figure 69). A close-up view of the reducer/elbow without the check valve can be seen in Figure 70. The time required to drain the container was measured to be 53 seconds.

Figure 70: Close-up of the reducer/elbow without the check valve.

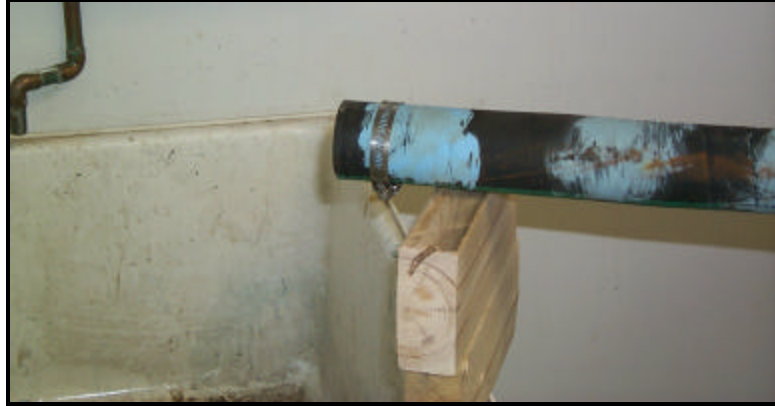
This system is identical to the one above with the exception that there is no check valve or reducer/elbow at the end of the supply system (see Figure 71). A close-up view of the filler tube without the reducer elbow or the check valve is shown in Figure 72. The time required to drain the container was measured to be 38 seconds.

Figure 72: Close-up of the fuel supply tube without reducer elbow or check valve.
