A Second Possible Cause of SUA In Mitsubishi Montero Sport Vehicles

Ronald A. Belt
Plymouth, MN 55447
22 September 2018

Abstract: A new cause of sudden unintended acceleration (SUA) has been found in Mitsubishi Montero Sport vehicles. The new cause arises from a known sticking defect in the Denso suction control valve used to meter fuel to the common rail and from a known ECU learning operation used on the Mitsubishi vehicle assembly line to correct for manufacturing variations in the fuel system components. These known vehicle features cause sudden unintended acceleration during engine idling in much the same manner as a negative voltage spike affects the battery voltage compensation function, leading to the same vehicle behavior relative to the idle and cruise engine controllers and the shifting of the transmission out of PARK and into DRIVE. Therefore, everything discussed to date about how the battery voltage compensation function causes sudden unintended acceleration during engine idling applies as well to this new cause of SUA. However, the two causes of sudden acceleration are independent, leading to an increase in the incident rate for sudden unintended acceleration. This

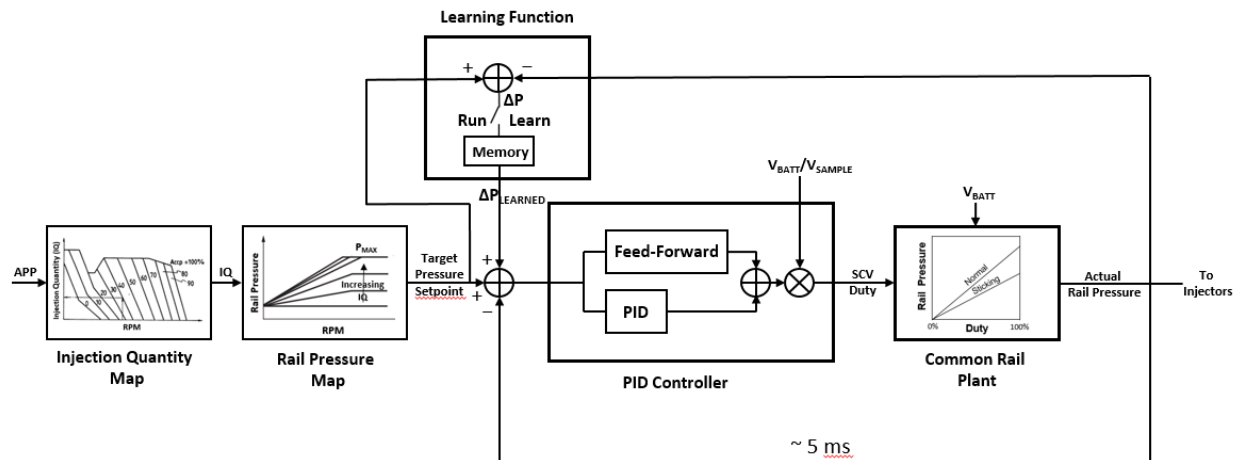
The way this learning is done is shown in Figure 10. Any difference ΔP between the actual rail pressure and the target rail pressure that persists after the engine speed has remained constant for a given period of time is detected by the learning function and stored in a memory inside the ECU. This difference is then added to the target rail pressure obtained from the vehicle's rail pressure map to either increase or decrease the target rail pressure as needed to make the actual rail pressure become equal to the compensated target rail pressure. The ΔP difference is applied only to the I-term in the PID controller, with the other two PID terms remaining unaffected²².

Figure 10. Rail pressure control system showing a learning function to eliminate manufacturing variations and aging variations represented by different transfer functions in the common rail plant.

There is one more consequence of the actual rail pressure increasing as a result of a learning correction being applied to the target rail pressure. Notice in Figure 10 that the target rail pressure is obtained from a pressure map that has the engine RPM as one of its axes and the injection quantity as the other axis. Note also that this map is fed by an injection quantity map that has the engine RPM as one of its axes and the accelerator pedal depression on the other axis. Therefore, if the engine speed increases for some reason, the injection quantity selected from the injection quantity map can increase, mimicking an increase in accelerator sensor input, even though the accelerator pedal sensor input remains unchanged. This can cause the target rail pressure to increase. But we have just discussed how the actual rail pressure can increase even though the target pressure remains the same, and we know that increasing the actual rail pressure causes the engine RPM to increase. Therefore, it is possible for a runaway condition to exist whereby the actual rail pressure increases because of an incorrect learning value even though the target pressure remains the same, causing the engine RPM to increase, causing the injection quantity to increase, and causing the target pressure to increase. Since this loop takes only about 15 milliseconds to traverse, one can traverse it over 66 times in one second, causing a small increase in the learning correction value to suddenly produce a large change in actual rail pressure, leading to runaway engine RPM.

Even worse, notice in Figure 10 that the slope of the curves for a fixed accelerator opening in the injection quantity map are all in the downward direction. This means that if the engine speed is reduced by some load on the engine, such as applying the brakes or the vehicle running into some movable object, then the injection quantity increases to cause the engine torque to increase even though the accelerator position sensor input does not change. The sensation the driver gets is that the harder he/she applies the brakes the more torque the engine produces, much the same as the engine torque increases when a vehicle goes up a hill with the cruise control on. This may be the reason that some drivers who have experienced sudden acceleration state that pressing harder on the brakes caused the engine to accelerate more forcefully.
