Tesla Regen, Brakes and Sudden Acceleration

Ronald A. Belt
Plymouth, MN 55447

1 June 2020

Abstract: EDR log data from a Tesla sudden acceleration incident is presented. To explain the EDR data, the operation of Tesla's drive motor control system and braking system are examined. As expected, friction braking and regen are completely separate with no blending. The braking system, however, includes several vehicle stability control functions that have a profound effect on regen operation in the presence of wheel slip, such as stopping regen when going over bumps and while turning corners. One of these slip control functions can cause the drive motor to speed up if regen is causing slip in the rear drive wheels that can lead to an oversteer or understeer. This same slip control function can be misled by a defective brake light switch to confuse a brake-induced deceleration for a regen-induced deceleration, in which case the harder a driver presses on the brake pedal, the larger a positive motor torque is produced. This is believed to be the cause of sudden acceleration in over 70% of Tesla vehicles.

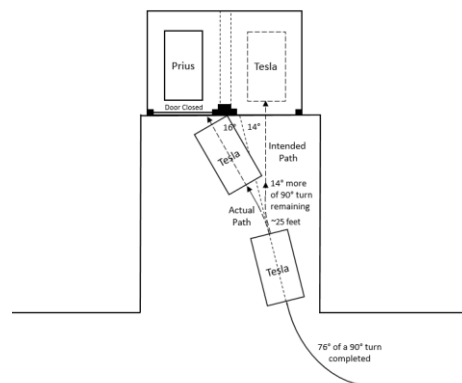
Fig 2. Vehicle path for the incident as inferred from the EDR data

Figure 2 shows the vehicle path during the incident. The street and driveway were both flat and on the same horizontal level. Figure 3 shows the EDR data for the pre-crash values of the accelerator pedal (%), rear motor speed (RPM), and vehicle speed (MPH). The accelerator pedal data shows that a value of 80% was reached one second prior to the crash. The vehicle speed data shows that the speed changed from 6 MPH before the crash to 14 MPH at the time of the crash. These alone might suggest that the driver pressed on the accelerator pedal to cause the crash. However, the pre-crash accelerometer data tell a different story.

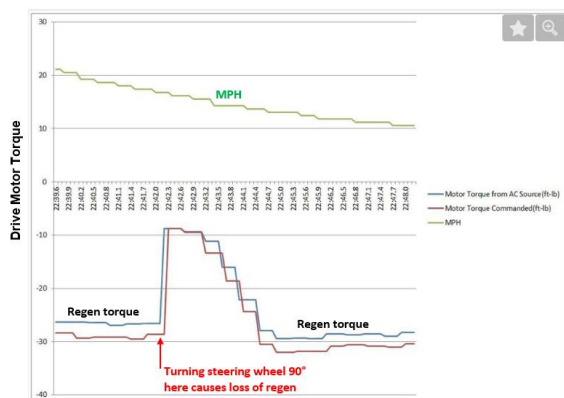
I measured this on my car [a Ford Fusion hybrid] ... [Figure 28] shows a chart of the vehicle speed and traction motor torque when this loss of regen happens while turning left. This happens on smooth road surfaces, so the loss is not due to bumps causing the loss of regen. I maintain steady [brake] pedal pressure throughout this whole braking event. You can see the motor torque [regen torque] drop off. This is when I feel a surge ... The regenerative braking will cut out under specific circumstances and the car will feel like it's lurching forward instead of slowing down. The situation is: braking using only regen brakes; no friction brakes; steady pedal pressure; going 15-20 MPH; turning the steering wheel at least 90 degrees left or right; driving on smooth pavement. Data I have logged from the Secondary On-Board Diagnostics Module C (SOBDMC) indicates that the traction motor briefly reduces its negative torque, which causes the car to surge forward. In one instance that I logged, the negative torque shows around 48 ft-lbs and then suddenly drops to about 8 ft-lbs. The traction motor then gradually increases the torque back to the appropriate level. In another instance, the negative torque suddenly went from about 28 ft-lbs to 8 ft-

lbs. The drop in torque occurs in 1/10 of one second per my logged data. It takes about 2.5 to 3.0 seconds for the traction motor [regen torque] to return to the appropriate level of negative torque to stop the vehicle.

Figure 28. When the steering wheel is turned 90°, regen is lost and a forward surge is felt.⁴⁴

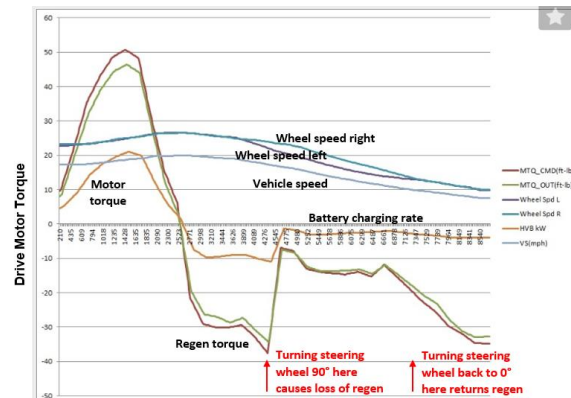
How sharp does the turn have to be and how fast to notice the problem? ... I'm not so sure that the steering wheel angle is all that important. I think it's more about the difference in wheel speed [Figure 29] I notice it most often when making left turns & slowing down, such as when turning into a parking lot or driveway. The lurch seems to happen between 15-20 MPH.

Figure 29. When the steering wheel is turned 90°, the wheel speeds change and regen is lost, causing a forward surge.⁴⁴

When braking and turning, the "operating as designed" behavior appears to be when the difference in wheel speed reaches a certain threshold. The car then reduces regen braking & blends in the friction brakes. This transition should be seamless & imperceptible. Since our car had the 14S21 & 15E03 recalls completed, this transition has become perceptible. This is the issue. The car is "operating as designed" to reduce regen while turning. The problem is that there is now a momentary delay between when regen is reduced and when the friction brakes are engaged. There shouldn't be a delay. The transition should be smooth & unnoticeable. Had any of us noticed that regen braking goes away when turning before this? No, we hadn't. That shows that the transition was working properly for everyone in the beginning. It's only recently that these issues have begun to be reported.

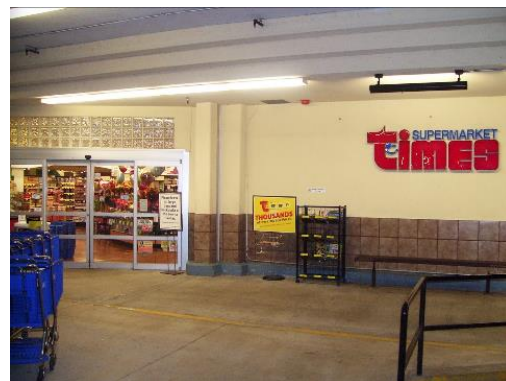
Figure 34. Close-up of store entrance showing the name of the supermarket.
