Tesla's Sudden Acceleration Log Data – What It Shows

Ronald A. Belt
Plymouth, MN 55447
1 May 2018

Abstract: Accelerator pedal sensor data from the log file of a Tesla S sudden acceleration incident is provided, and a Tesla circuit diagram is used to explain how the data is obtained from the two accelerator pedal position sensors. Examination of the data shows that the accelerator pedal sensor output increased to cause the sudden acceleration. But the increase in the accelerator pedal sensor output could not have been caused by the driver. Instead, the increase in the accelerator pedal sensor output appears to have been caused by a fault in the motor speed sensor, with which it shares a common+ 5V power and ground. This increase in pedal sensor output occurs without the driver pressing on the accelerator pedal. An explanation of how this increase can occur is provided, yielding a testable theory of sudden acceleration in Tesla vehicles. The theory applies to all Tesla S and Tesla X vehicles as a result of commonality in the design of their traction motor/inverter assemblies.

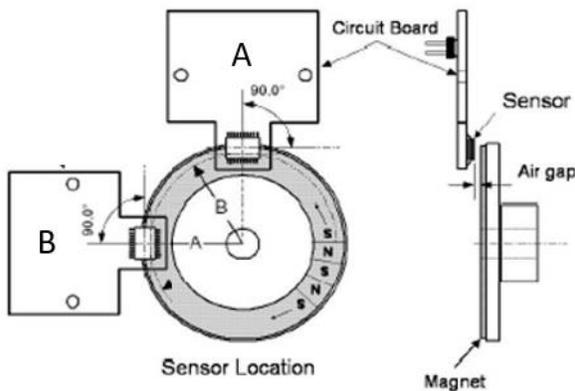
Two Hall effect switches are used to make a motor encoder as shown in Figure 6. The switches are placed 90° apart inside the traction motor housing so they can sense the alternating north and south magnetic fields embedded into a special ring pressed on the same shaft as the motor’s rotor. The magnetic fields are sensed through a small air gap that is only a few millimeters wide. The two digital outputs produce two square wave signals as shown in Figure 7. By examining the time sequence of the peaks in these two square wave signals, the motor control circuitry can determine both the motor speed and the direction of rotation. Rotational position of the motor is not sensed, and must be determined by the motor control algorithm.

Figure 6. Two Hall effect switches 90° apart are used to make the motor speed encoder.

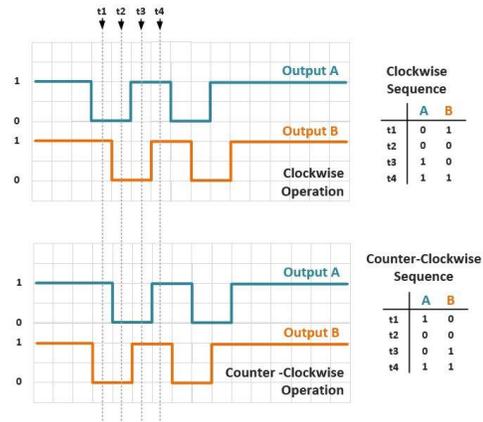
Figure 7. The two digital outputs can be used to sense the motor’s speed and direction of rotation.
