Michael A. Berardi
Director
Service Engineering Operations
Ford Customer Service Division

October 26, 2017

SUBJECT: **Customer Satisfaction Program 17N03 – Supplement #1**
Certain 2011-2017 Model Year Explorer Vehicles
Carbon Monoxide Concerns

REF: **Customer Satisfaction Program 17N03**
Dated October 25, 2017

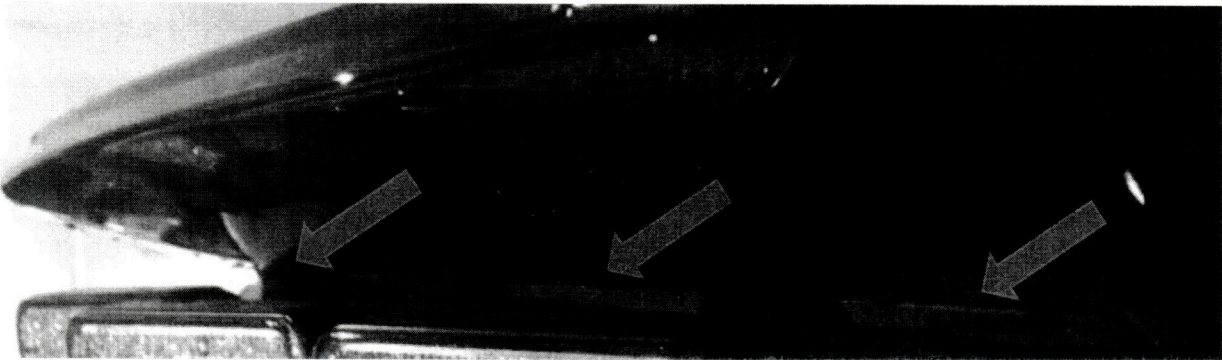
Figure 2

- Brackets positioned between the spoiler and the liftgate (See Figure 1)
- Lighting and/or equipment that forces the spoiler out of position creates a gap between the spoiler and the liftgate (See Figure 2)
- Unsealed holes drilled in the spoiler or liftgate (See Figures 3 and 4)
- Wiring for lighting and/or equipment routed from the spoiler to the vehicle in a manner that damages the seals between the spoiler and the vehicle (See Figures 5 and 6)
- When the spoiler is removed to install aftermarket lights and/or equipment, the spoiler attachment clips and seals may be damaged. If the spoiler was removed from the vehicle, the spoiler attachment clips and seals should be replaced. Use part number HB5Z-78442K03-A
