# NHTSA's 1989 Pollard and Sussman Report Concluding Pedal Confusion is the Cause of Audi 5000 SAI is Wrong

Ronald A. Belt  
Plymouth, MN 55447  
24 October 2025

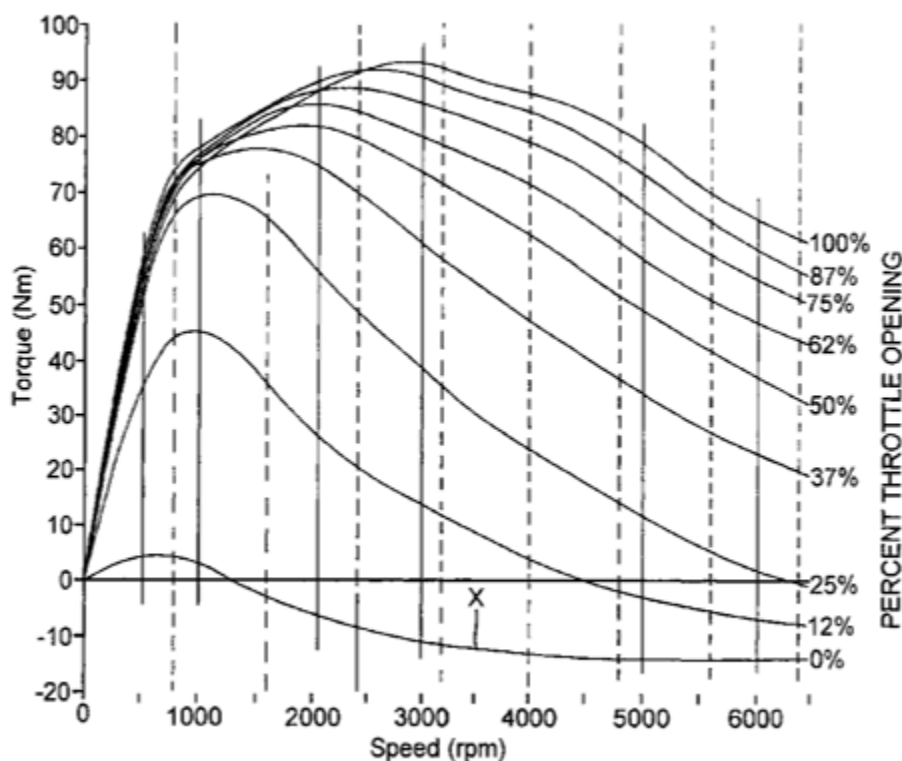
Figure 2. Engine torque versus engine RPM for a typical internal combustion engine, showing how engine torque varies with throttle opening. If the engine includes a turbocharger, then the maximum torque value will increase and the RPM value at which the torque is a maximum will decrease.

Therefore, Figure 1 is correct. It is unknown why Audi and NHTSA chose to omit the region between 0 RPM and 1000 RPM. But NHTSA's Pollard and Sussman report verifies that the Audi 5000 engine will operate at about 2000 RPM when the idle stabilizer valve is fully open, placing it right in the middle of this curve. And the report states further that this RPM allows a vehicle to reach vehicle speeds of 40 mph in a short time. Some drivers have even reported on the internet that their Audi 5000 vehicles will operate at up to 3000 RPM with the idle stabilizer valve fully open, which allows their vehicle to reach speeds of 60 mph in a short time. Therefore, an RPM range of 2000 to 3000 RPM is possible in an Audi 5000 with a fully open idle stabilizer valve. This is probably due to variations in the engine idle setting and variations in the idle stabilizer valve.

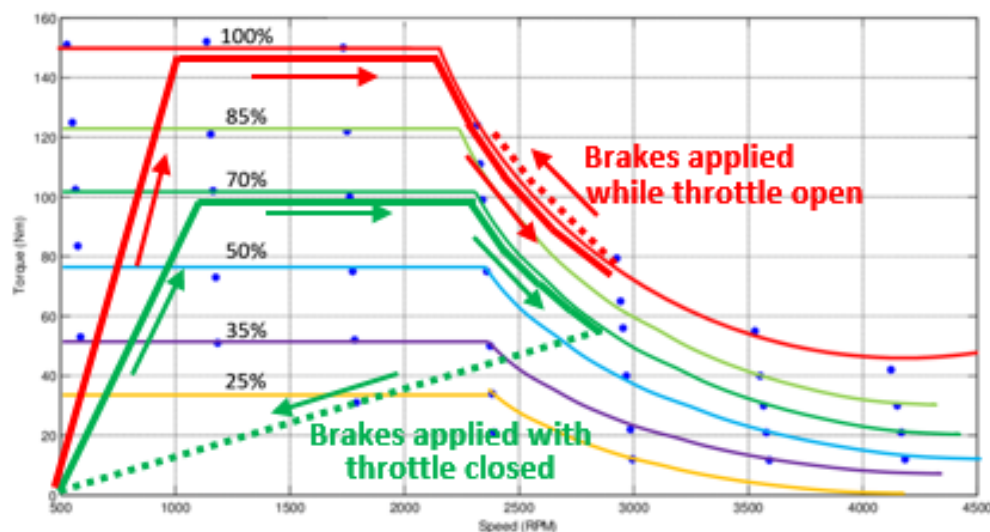
Figure 4. Motor torque versus motor speed for the drive motor of an electric vehicle. During normal operation the drive motor follows the green curve, causing the motor torque to decrease as the motor RPM's decrease while braking with the accelerator pedal released and no current applied to the motor. During sudden acceleration the motor follows the red curve, causing the motor torque to increase as the motor RPM's decrease while braking as current continues to be applied to the motor.<sup>[6]</sup> The increased motor torque counters the braking torque, giving the driver the impression that the brakes are failing.

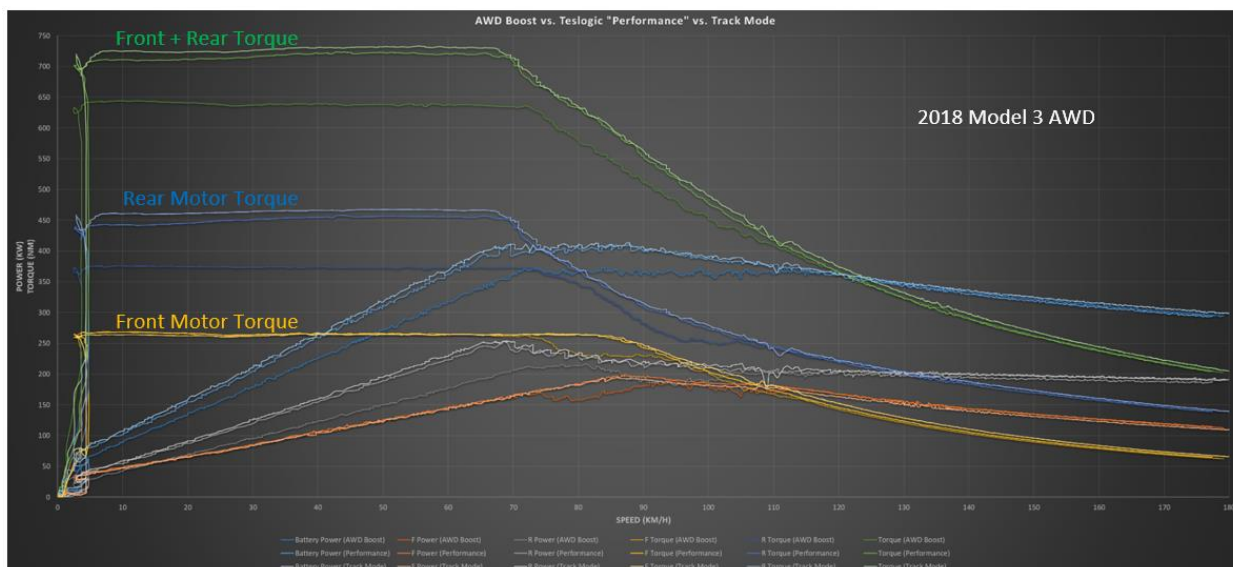
Figure 5. Motor torque versus vehicle speed for the two drive motors of a 2018 Model 3 Tesla with AWD. Only the maximum torques (100% throttle) are shown. Lower torques are

obtained by using lower accelerator pedal settings that apply proportionally lower currents to the motors.

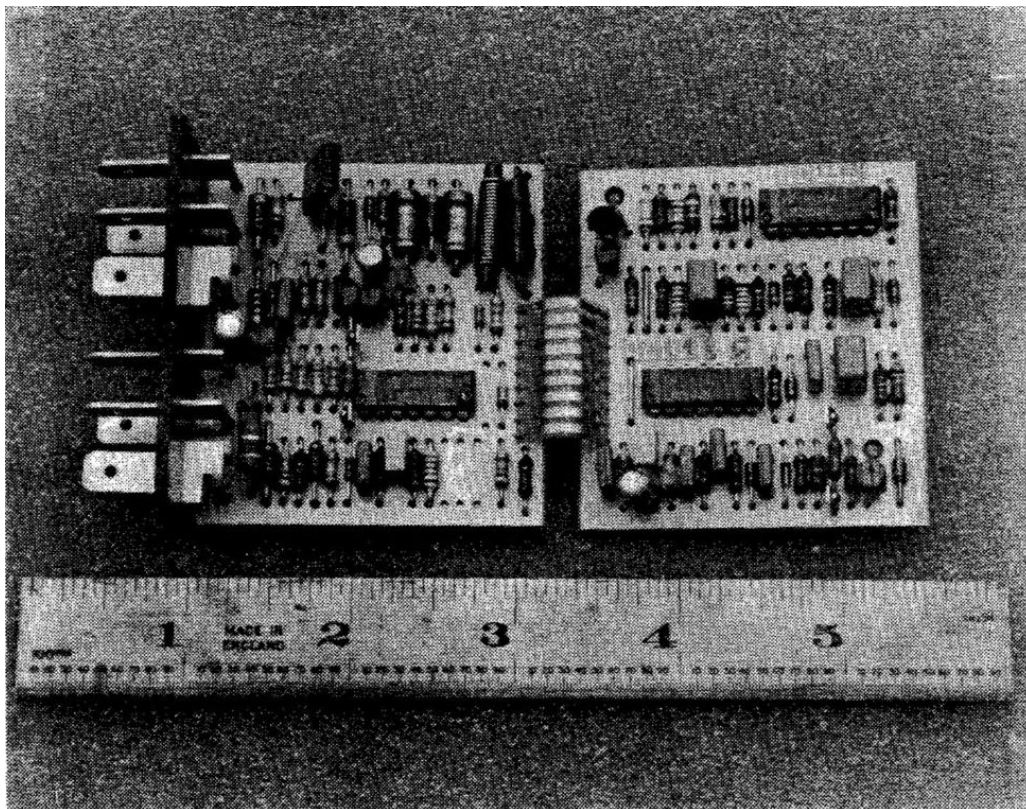
Figure A-1. Audi 5000 idle stabilizer control electronics as shown in Appendix H of the Pollard and Sussman report on page 3-12.

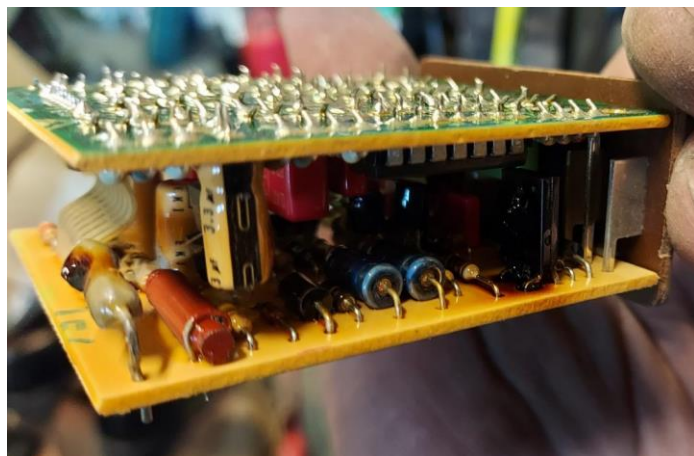
Figure A-4. Completely folded idle stabilizer electronics without housing.[3]

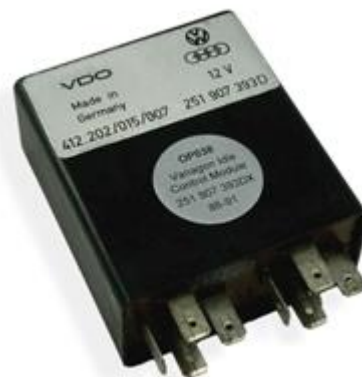
Figure A-5. Idle stabilizer electronics in its housing that fits under the driver side dashboard.
