1. Identify and describe the difference between the recalled cruise control computer and the improved design computer to be installed as a remedy.
2. Identify and describe the nature of the defect, its failure modes, and the specific components which can result in the malfunction or failure. The description should include an identification of the following:

Toyota will initiate a special service campaign to replace the factory installed cruise control computer with an improved design on certain 1983 and 1984 Toyota Camrys and 1984 Corollas.

Shutting off the cruise control after extensive continuous use followed by exposure to extremely cold ambient conditions may result in excessive thermal shock to the cruise control computer. Repetition of this cycle may lead to a cruise control computer malfunction.

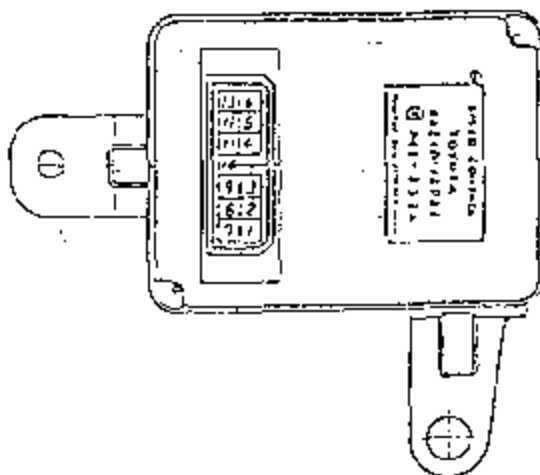
Fig 1 Connector terminal

Table 2 Voltage at the connector terminals (Yves Arcouet Case)

No.	Terminals	Voltage (V)		Judgement
		failed part	normal part	
1	Release Valve	9.7	0.0	NG
2	Gnd	0.0	0.0	OK
3	Control Valve	10.1	0.0	NG
4	SET/COAST S/W	11.2	11.2	OK
5	T/M Control Relay	12.0	12.0	OK
6	Speed Sensor	10.9	10.1	OK
7	Main S/W	12.0	12.0	OK
8	Stop Lamp S/W	0.0	0.0	OK
9	Stop Lamp Fuse	12.0	12.0	OK
10	Gnd	0.0	0.0	OK
11	Neutral Start S/W	10.7	10.9	OK
12	Parking Brake S/W	12.0	12.0	OK
13	RESUME/ACCEL S/W	11.2	11.2	OK

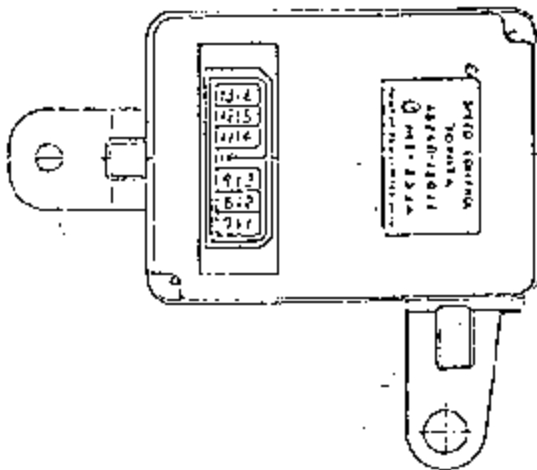
Fig 2 Connector terminal

Table 3 Voltage at the connector terminals (Gilbert Pinet Case)

No.	Terminals	Voltage (V)		Judgement
		failed part	normal part	
1	Release Valve	9.8	0.0	NG
2	Gnd	0.0	0.0	OK
3	Control Valve	10.1	0.0	NG
4	SET/COAST S/W	11.2	11.2	OK
5	T/M Control Relay	12.0	12.0	OK
6	Speed Sensor	10.9	10.1	OK
7	Main S/W	12.0	12.0	OK
8	Stop Lamp S/W	0.0	0.0	OK
9	Stop Lamp Fuse	12.0	12.0	OK
10	Gnd	0.0	0.0	OK
11	Neutral Start S/W	10.7	10.9	OK
12	Parking Brake S/W	12.0	12.0	OK
13	RESUME/ACCEL S/W	11.1	11.2	OK

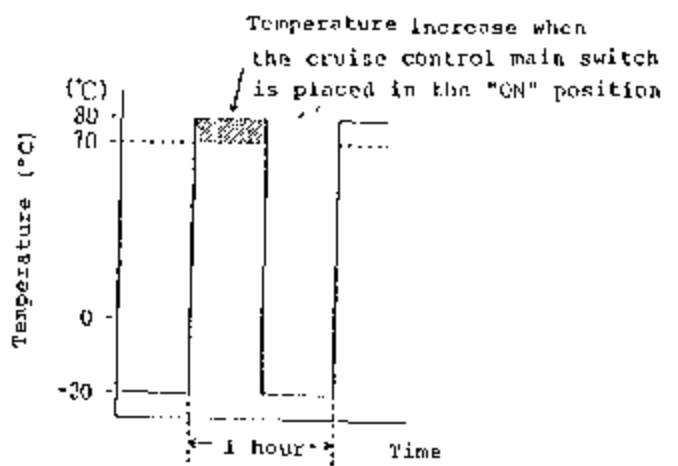
Fig. 1 Test Method

Thermal shock test was conducted for the subject computer using the cycle shown in Fig.1, which was used during the development stage.

As a result, there were no abnormalities as shown Fig.2.

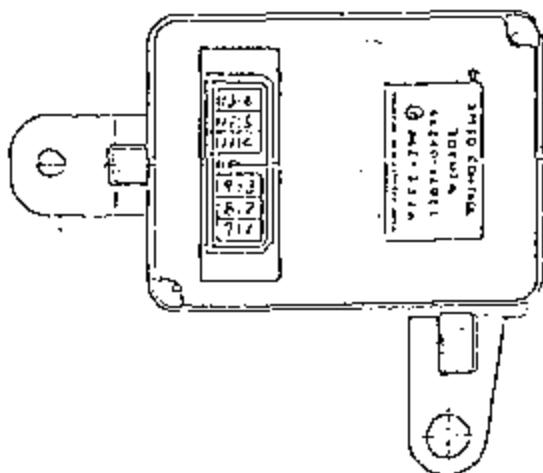
Fig 1 Connector terminal

Table 2 Voltage at the connector terminals (Yves Arcouet Case)

No.	Terminals	Voltage (V)		Judgement
		failed part	normal part	
1	Release Valve	9.7	0.0	NG
2	Gnd	0.0	0.0	OK
3	Control Valve	10.1	0.0	NG
4	SET/COAST S/W	11.2	11.2	OK
5	T/M Control Relay	12.0	12.0	OK
6	Speed Sensor	10.9	10.1	OK
7	Main S/W	12.0	12.0	OK
8	Stop Lamp S/W	0.0	0.0	OK
9	Stop Lamp Fuse	12.0	12.0	OK
10	Gnd	0.0	0.0	OK
11	Neutral Start S/W	10.7	10.9	OK
12	Parking Brake S/W	12.0	12.0	OK
13	RESUME/ACCEL S/W	11.2	11.2	OK

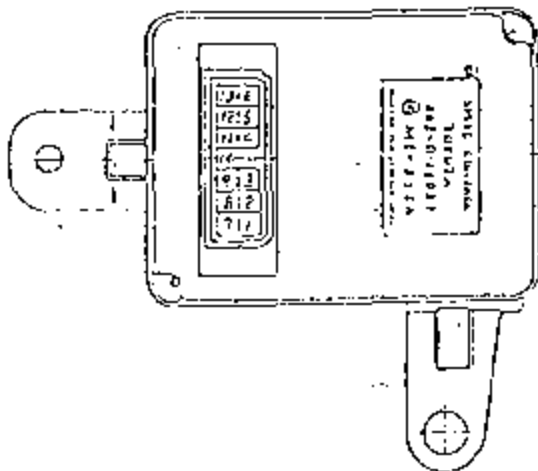
Fig 2 Connector terminal

Table 3 Voltage at the connector terminals (Gilbart Pinet Case)

No.	Terminals	Voltage (V)		Judgement
		failed part	normal part	
1	Release Valve	9.8	0.0	NG
2	Gnd	0.0	0.0	OK
3	Control Valve	10.1	0.0	NG
4	SET/COAST S/W	11.2	11.2	OK
5	T/M Control Relay	12.0	12.0	OK
6	Speed Sensor	10.9	10.1	OK
7	Main S/W	12.0	12.0	OK
8	Stop Lamp S/W	0.0	0.0	OK
9	Stop Lamp Fuse	12.0	12.0	OK
10	Gnd	0.0	0.0	OK
11	Neutral Start S/W	10.7	10.9	OK
12	Parking Brake S/W	12.0	12.0	OK
13	RESUME/ACCEL S/W	11.1	11.2	OK

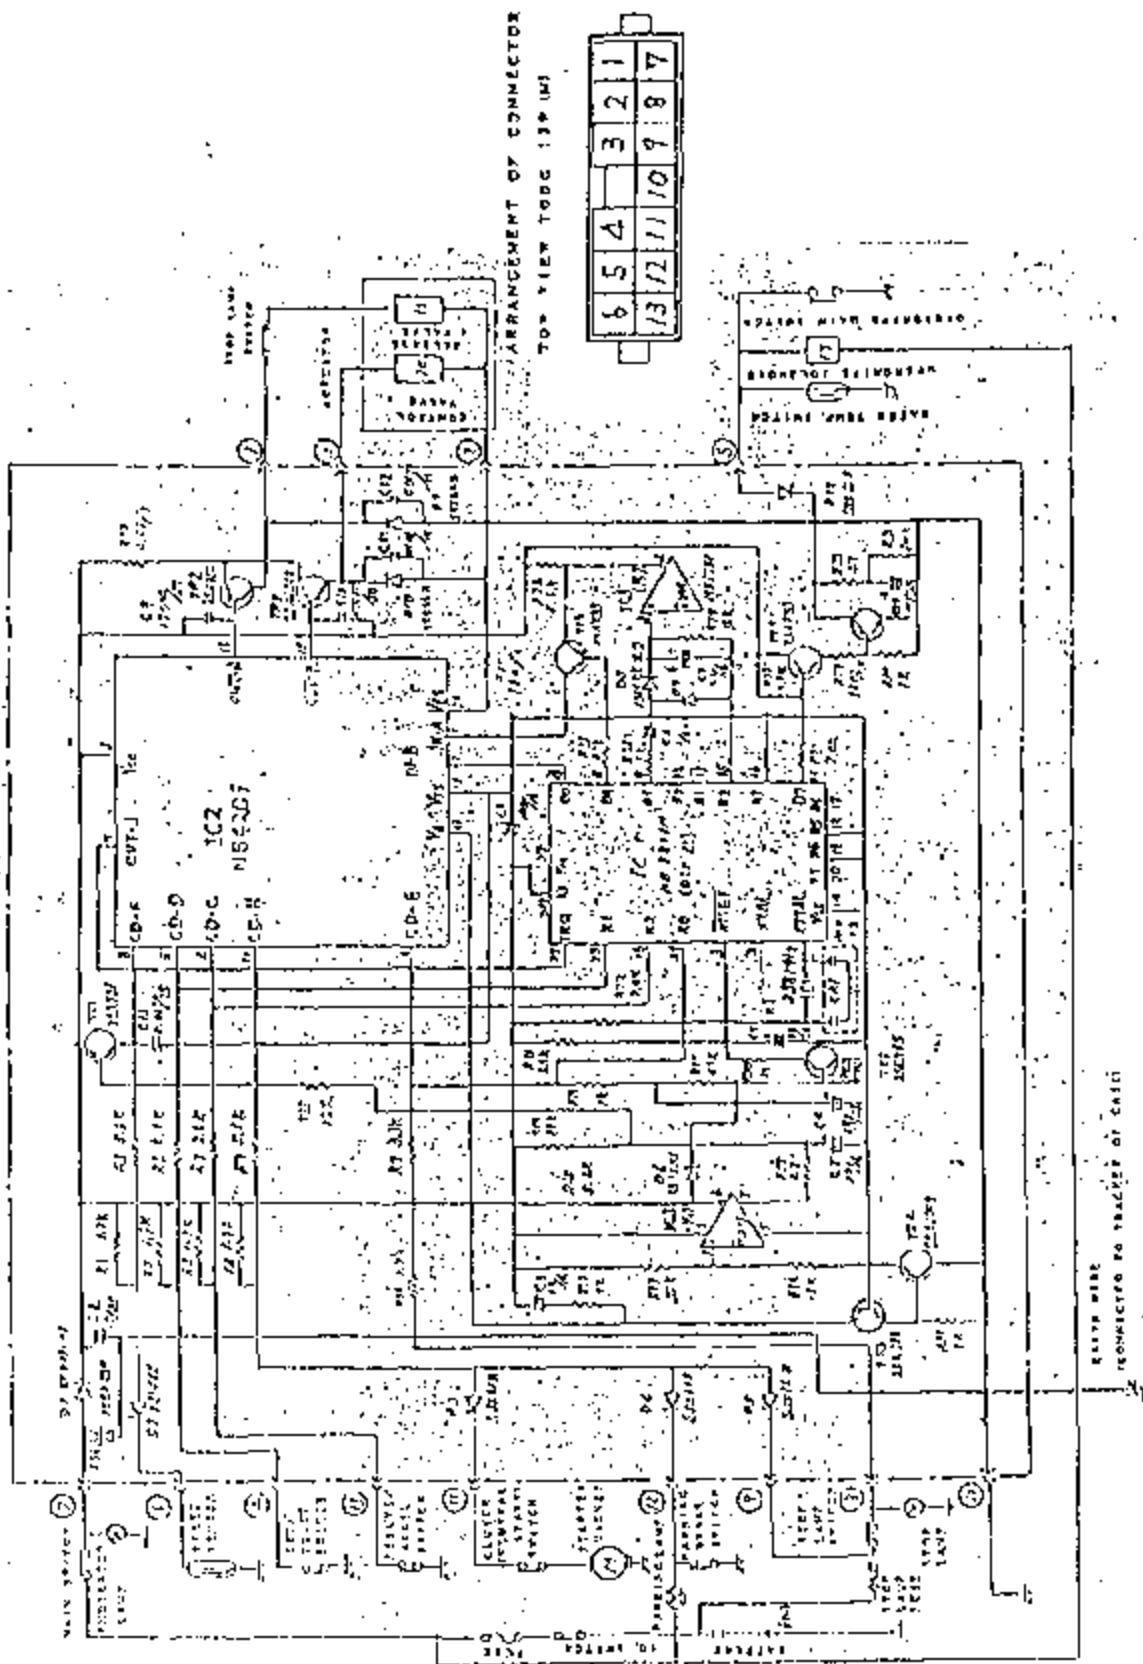
Fig 3 Cruise control computer circuit diagram

Although the voltage at the No.1 and No.2 terminal of the custom I.C., which are terminals that receive the control signal from the microprocessor, were normal, there existed a voltage level difference between the failed part and the normal part. The voltage at the No.15 and No.16 terminals, which are terminals that output the signal to the transistors, was abnormal resulting in continuous of activation of these transistors.

The voltage at the No.12 and No.13 terminal of the custom I.C., which are terminals for the power source and the voltage of the transistor TR4 (for the power source control) were abnormal.
