U.S. Department
of Transportation

National Highway
Traffic Safety
Administration

NSA-111jdw
95V-103

SUBJECT: Seat Belt Buckle Failures in Vehicles Equipped with Takata Seat Belts

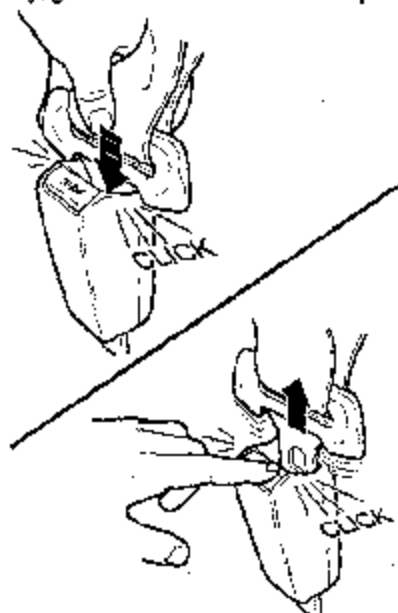
- If both buckles latch and unlatch properly, continue to **Button Inspection**.
- If either buckle does not latch or unlatch properly, go to **Seat Belt Buckle Replacement**.

1. Push the seat belt latch plate into the buckle. They should latch together with a sharp click. Push the **PRESS** button to release the latch plate from the buckle. It should release with a sharp click and the latch plate should pop out of the buckle.

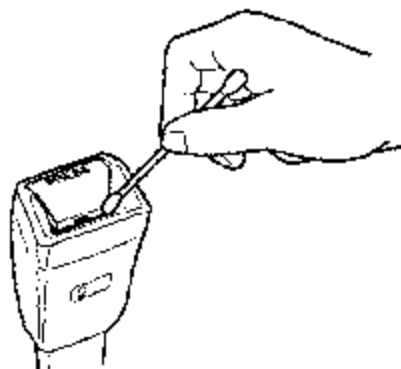
- Using the Buckle Inspection Mirror (see TOOL INFORMATION) and a bright light, examine the release button for chips or cracks.

1. Wet a cotton swab with a five percent soap and water solution. Clean the inside edge of the release button.
