EA12-005 Reconstruction Testing for KJ Jeep Liberty and ZJ Grand Cherokee

July 2014

U.S Department of Transportation
National Highway Traffic Safety Administration

6. Performing Organization Code NVS-313	
7. Author(s) William D. Collins, NHTSA Engineer				8. Performing Organization Report No. VRTC Report DCD3208

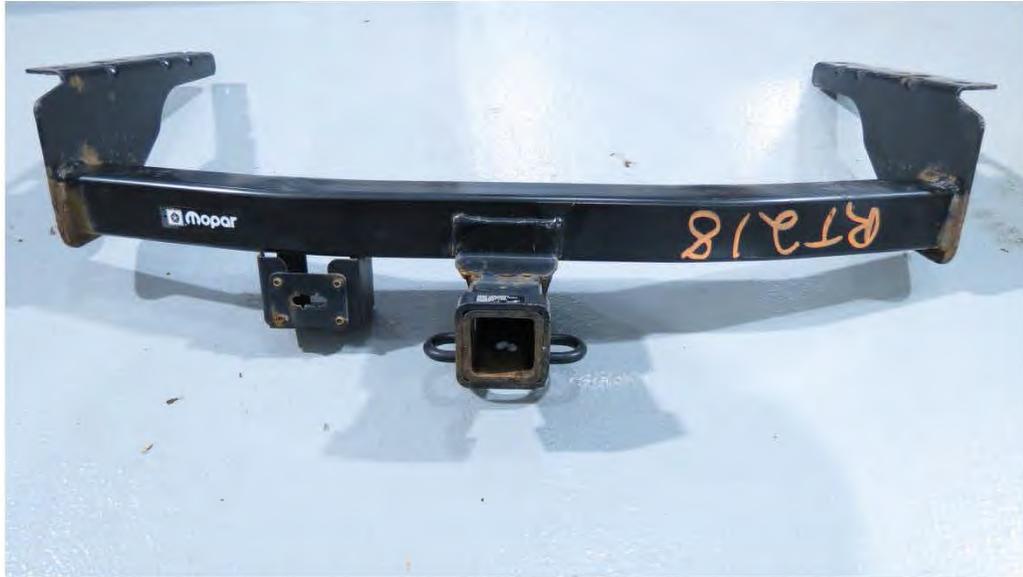
Figure 1 – Jeep Liberty hitch-receiver

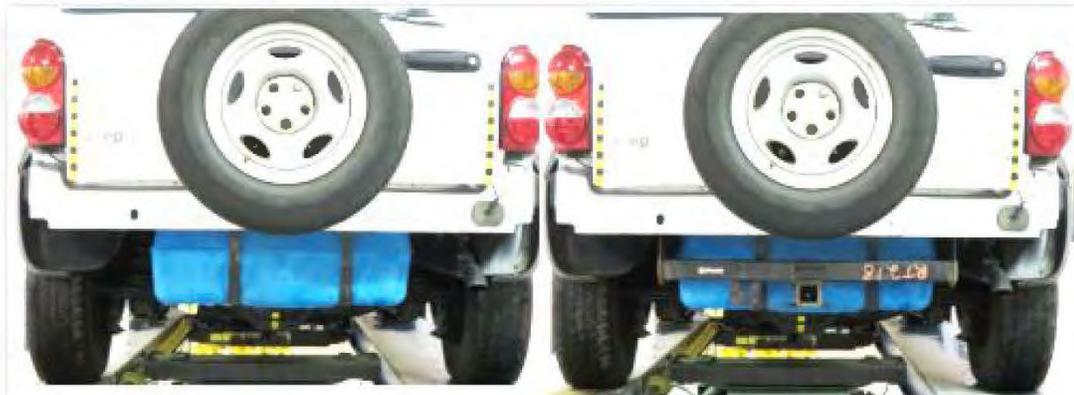
Figure 2 - Jeep Liberty without hitch-receiver and with hitch-receiver installed

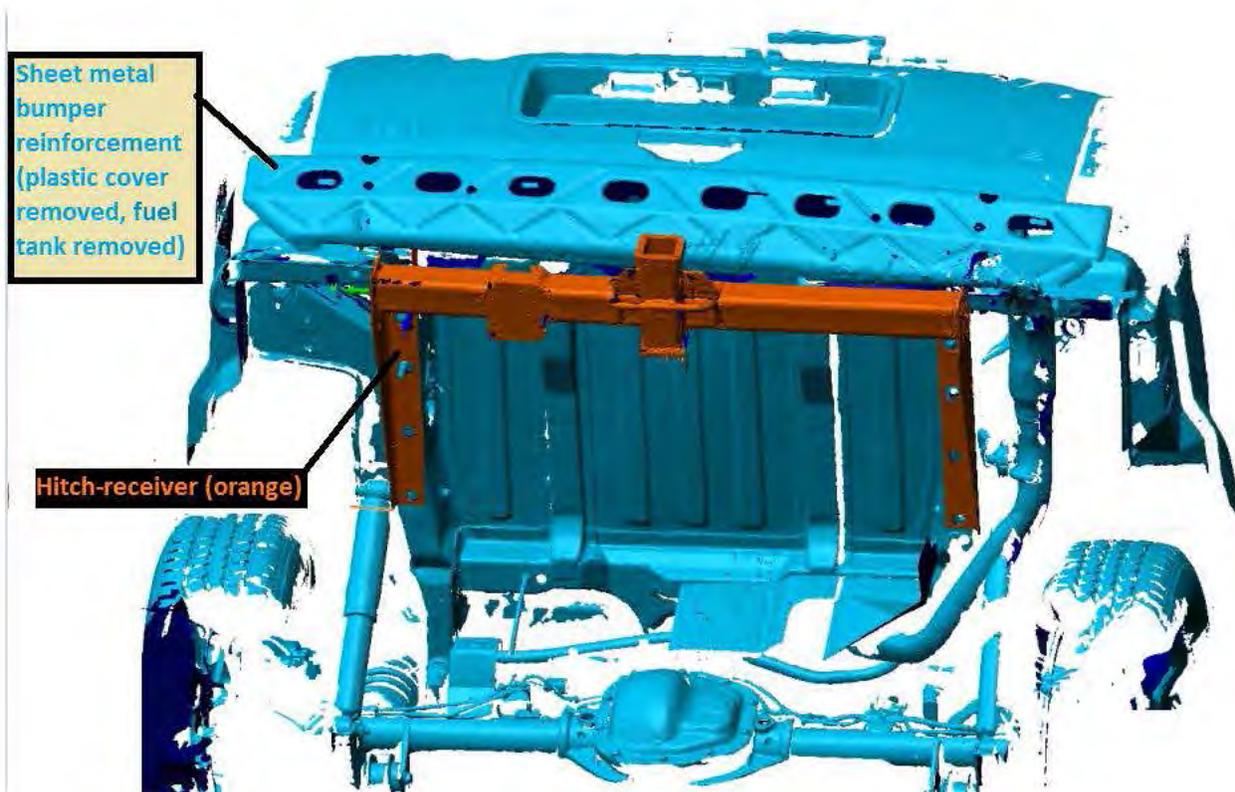
The 1993-1998 Jeep Grand Cherokee is similar, but instead uses a sheet metal bumper reinforcement beneath the plastic bumper cover that can be seen in the digitally measured rendering above the installed hitch-receiver, shown in Figure 3.

Figure 3 - Grand Cherokee 3D scan, hitch-receiver in orange, fuel tank removed

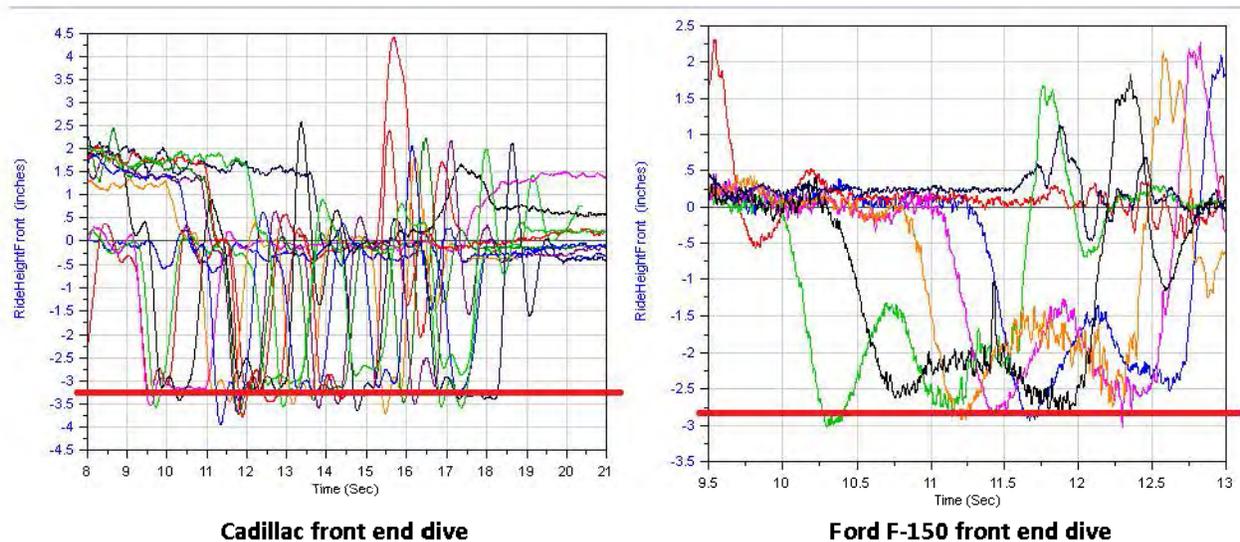
Vehicles were tested multiple times at their maximum deceleration rate from velocities ranging from 32 to 55 mph in order to find the average of the maximum relative change in front ride height. The ride height time-histories for the Cadillac Deville and Ford F-150 are shown in Figure 4, respectively, and their average results are indicated by the horizontal red lines shown in Table 3.

Figure 4 – Cadillac Deville and Ford F-150 front end dive (pitch) under maximum braking

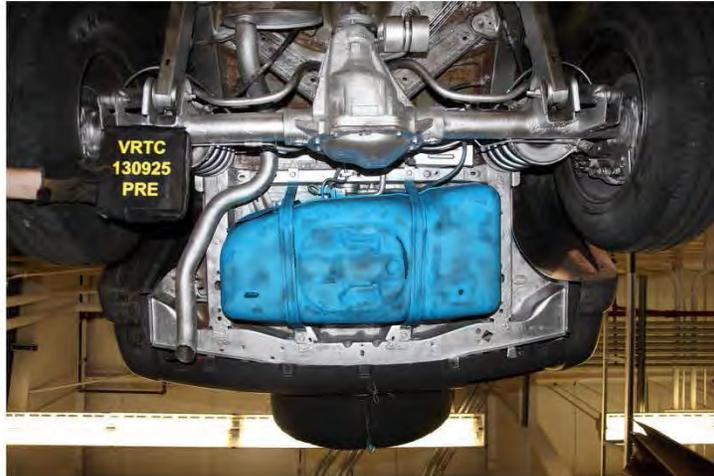
Figure 8 – Test #1 Pre-test target vehicle rear underbody view without hitch-receiver

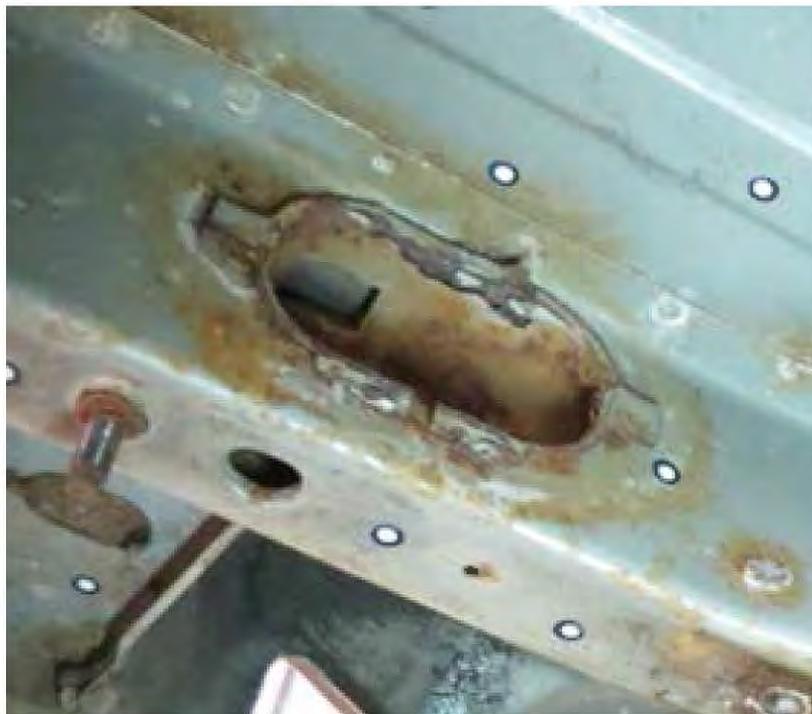
Figure 11 - Frame rail relief tunnel for fuel filler hoses

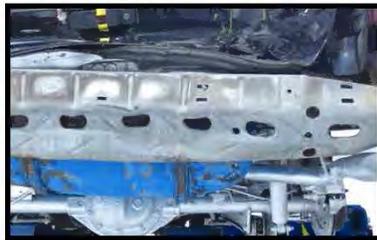
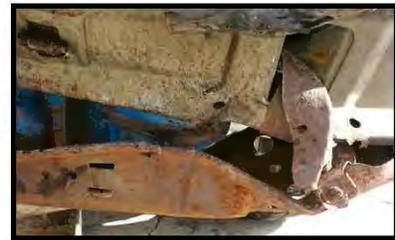
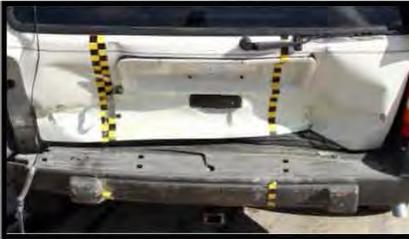
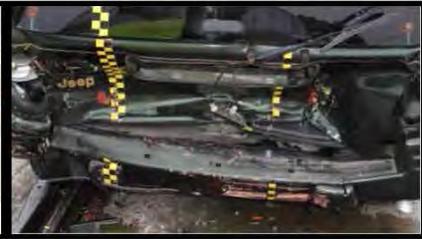
Figure 18 - Comparison of post-crash damage of the rear bumper reinforcement area between the baseline tests and the real-world crash

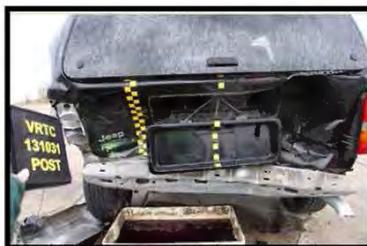
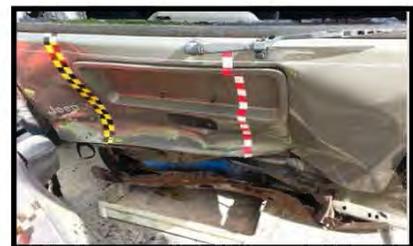
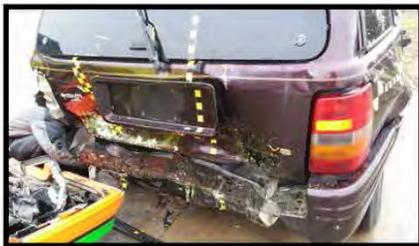
Figure 19 - Comparison of post-crash damage of the rear lift gate area between baseline test and real-world crash

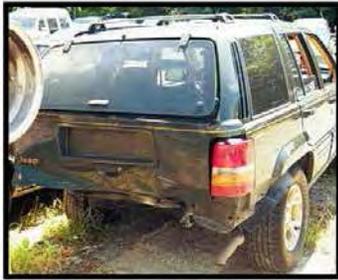
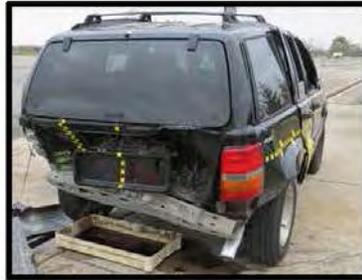
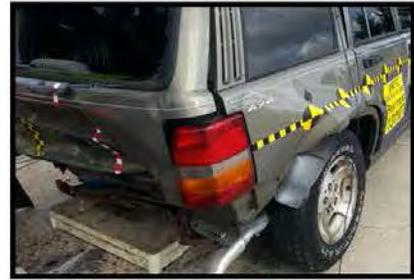
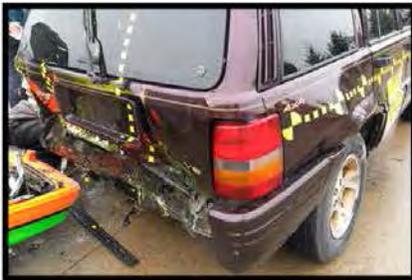
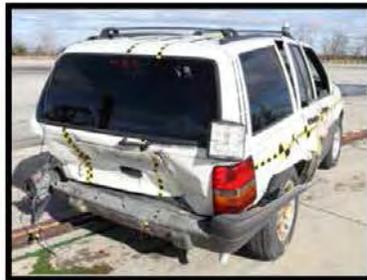
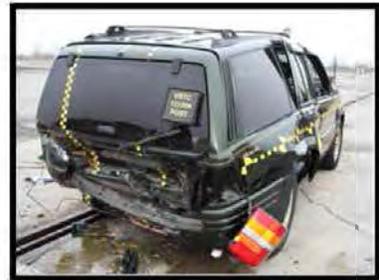
Figure 20 - Comparison of post-crash damage of right rear area between baseline test and real-world crash

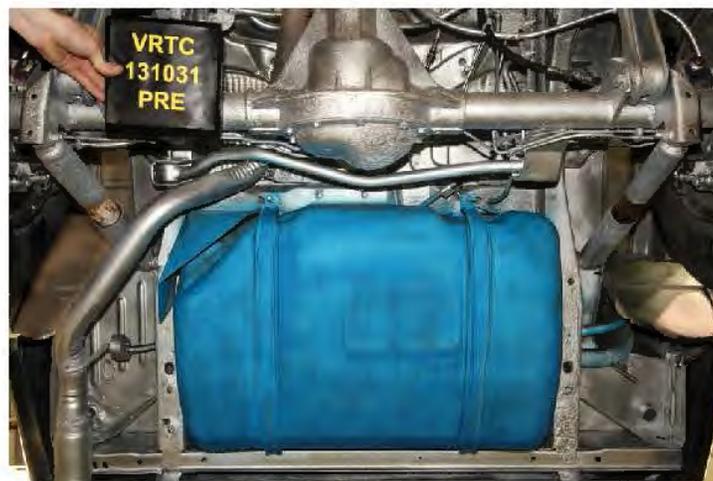
Pre-test and post-test photos of the target vehicle fuel tank from the baseline test (Test#3) are shown in Figure 23 and Figure 24, respectively. The post-test photo shows the scraping caused by the under-ride. Figure 25 shows the post-test photo of the comparative test (Test #7) with hitch-receiver installed. The fuel tank did not show signs of under-ride, but did show signs of impacting the rear differential of the Jeep.

Figure 23 - Test #3 Pre-test target vehicle fuel tank close-up view without hitch-receiver

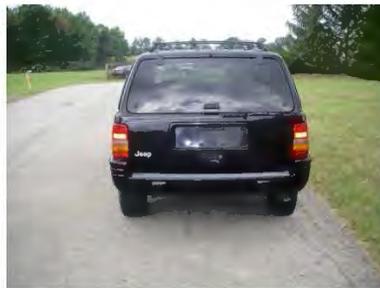
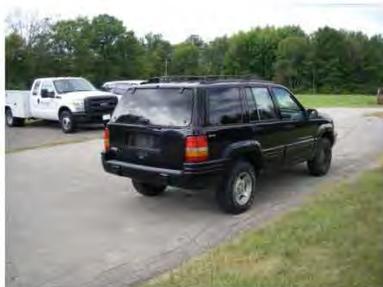
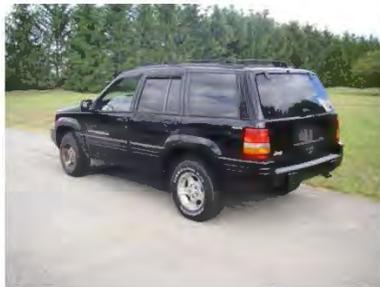
1998 Jeep Grand Cherokee
VIN: 1J4GZ48S1WCxxxxxx
Target Vehicle Test# 3

The reconstruction of the Cadillac Deville into the ZJ Jeep Grand Cherokee revealed a repeatable failure mode with the crushed and rusted frame rail pulling on the fuel filler hoses until they broke the connections from the plastic tank. It was confirmed that a vehicle with little to no rust could withstand the crash. The hitch-receiver bracket and mounting bolts provided a structural reinforcement that prevented the collapse of the moderately rusted frame rail relief tunnel in testing.

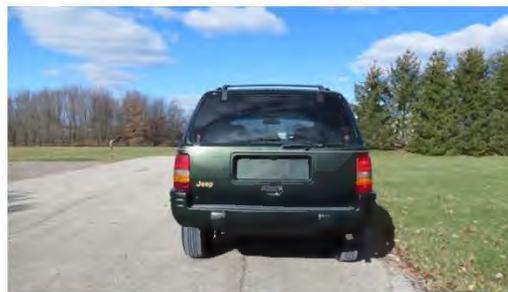
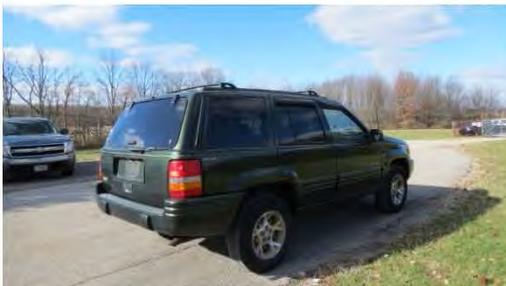
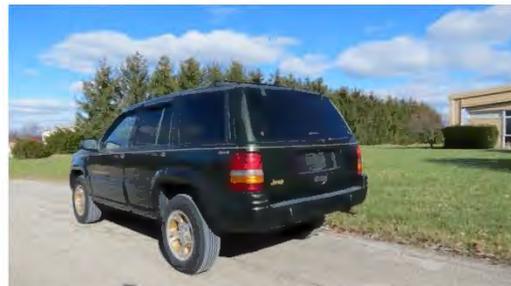
1996 Jeep Grand Cherokee
VIN: 1J4EZ78S9TCxxxxxx
Target Vehicle Test# 7

Varying the height of the bullet vehicle by approximately zero to three inches did not prove to be relevant to the failure mode. The stepped front bumper of the Cadillac caused a partial under-ride and contributed to these vehicles crushing the fuel tank in a crash when the Jeep was not equipped with a hitch-receiver. When the hitch-receiver was installed, a reduced level of rear structure and fuel tank crush occurred.

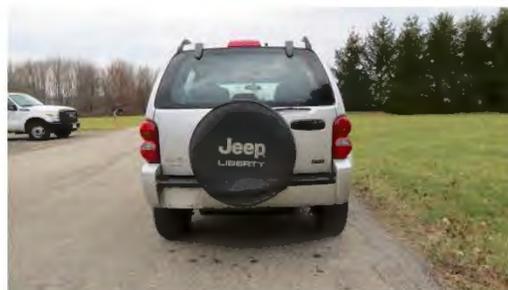
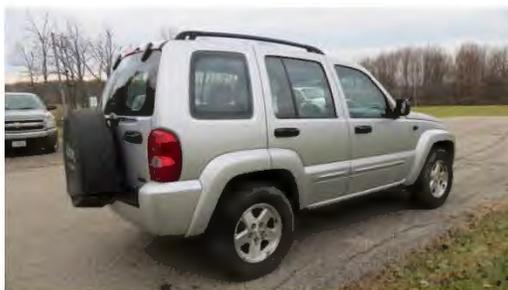
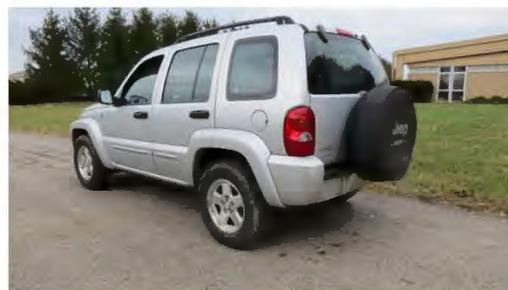
2004 Jeep Liberty, VIN: 1J4GL58K94Wxxxxxx
Target Vehicle Test# 8

The reconstruction of the F-150 into the KJ Liberty demonstrated the hitch was capable of withstanding a higher energy impact without the hitch-receiver cross-member fracturing and without piercing the tank. Damage to the tested Jeep Liberty indicated that the energy levels were consistent with, if not in excess of that achieved in the real-world crash. The presence of the aftermarket tow drawbar and tow ball inserted into hitch-receiver in the real-world crash seems to have increased the leverage acting upon the cross-member and may have contributed to the overload fracture. The droplets of fuel leakage during and immediately after the test that originated from the vent and vapor tube connectors ceased shortly after the impact. Significant leakage did not occur until the vehicle was rolled in the rollover fixture. The source of the leak was the overfill vent connector and the charcoal vapor connector, which had broken off of the top of the fuel pump assembly.
