Service Action Circular

Code: WG

June 2004

Subject: 2001–2003 Model Year Volkswagen Vehicles Replace Ignition Coils

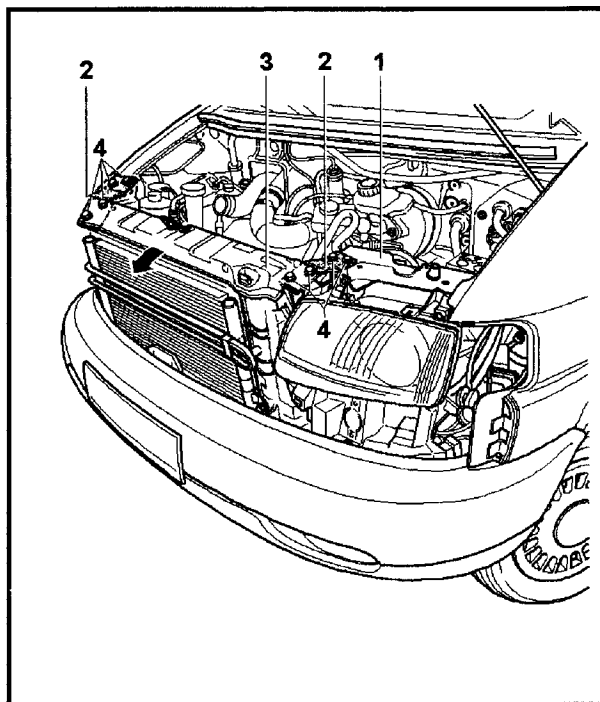
- ⇐ Remove lock carrier bolts -1- on left and right sides

⇐ Pivot the lock carrier -3- with radiator in the forward direction -arrow-

⇐ Attach latch tool T10253 -2- between lock carrier -3- and mounting panel for headlight -1- on both left and right sides using bolts -4-
