Further Details on an Electronic Mechanism for Sudden Unintended Acceleration

Ronald A. Belt
Plymouth, MN 55447
6 January 2014

Abstract: Further details are presented on the author's hardware theory of sudden acceleration. The new details show how long term sudden acceleration is created by the target throttle opening changing due to feedback of the engine RPM even when the accelerator pedal is released. Another detail explains why many drivers in longer term sudden acceleration incidents have observed that the vehicle accelerated as they pressed on the brake pedal. The theory also explains why engine surges and longer term sudden acceleration events occur in the vehicles of all automobile manufacturers. Approaches for preventing sudden unintended acceleration are described, and a method of eliminating the consequences of a runaway engine after sudden acceleration begins is presented.

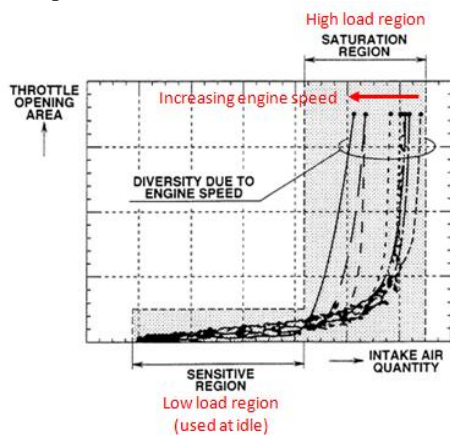
Figure 9. The intake air quantity (cylinder air charge) decreases with engine speed at large throttle openings because of air pressure changes, making engine torque a function of both throttle opening area and engine speed.

All of these vehicle-controlled functions require fine control over the engine torque. Such fine control cannot be achieved using a single map of the accelerator pedal to the throttle opening. This is because the air intake quantity (i.e., cylinder air charge) which determines the engine torque is not a fixed function of the throttle opening area, but varies with engine speed as shown in Figure 9 as a result of the difference in air pressure between the throttle valve and the engine cylinders becoming smaller at higher engine speeds¹⁰. This means that the transfer function between the accelerator pedal position and the engine torque (i.e., the driver demand map) depends on the engine speed as shown in Figure 10. A driver with a mechanical throttle can easily accommodate these changes in transfer function with engine speed by pressing harder on the accelerator pedal. But an electronic control system cannot do this as easily. Therefore, engine speed must be included as a parameter in the driver demand map and in the inverse engine torque map.

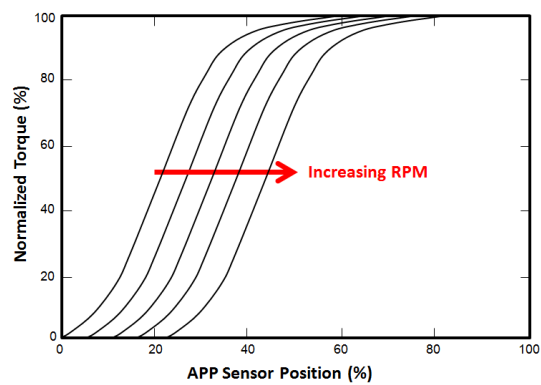
Figure 10. The map of actual engine torque versus accelerator pedal position (pedal map) varies with engine speed, requiring engine speed to be included in the throttle maps.

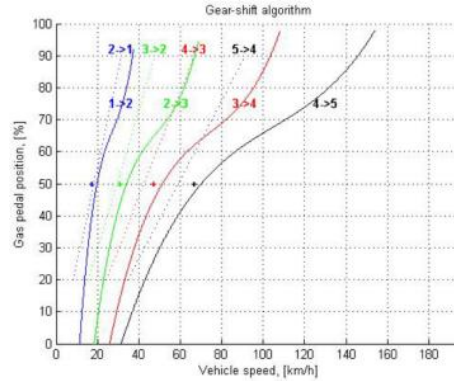
Fig 12. Under higher acceleration (higher torque) demand, the transmission spends a longer time in the lower gears¹².

2. Transmission Shift Control. An electronic transmission (used now by all auto manufacturers) uses the driver-demanded torque and the vehicle speed as inputs to a shift scheduling map to determine when to shift gears, as shown in Figures 11 and 12. The actual shifting is done by electronic solenoids. Older mechanical transmissions used the engine load, or the throttle valve position as determined by a throttle position sensor, as a measure of the actual engine torque instead of using the driver-demanded torque, and used a governor valve controlled by vehicle speed, instead of a crankshaft sensor, to determine the transmission output shaft speed, which then determined when to shift the gears. The actual shifting in a mechanical transmission was done by oil control valves which switched as a function of oil pressure.

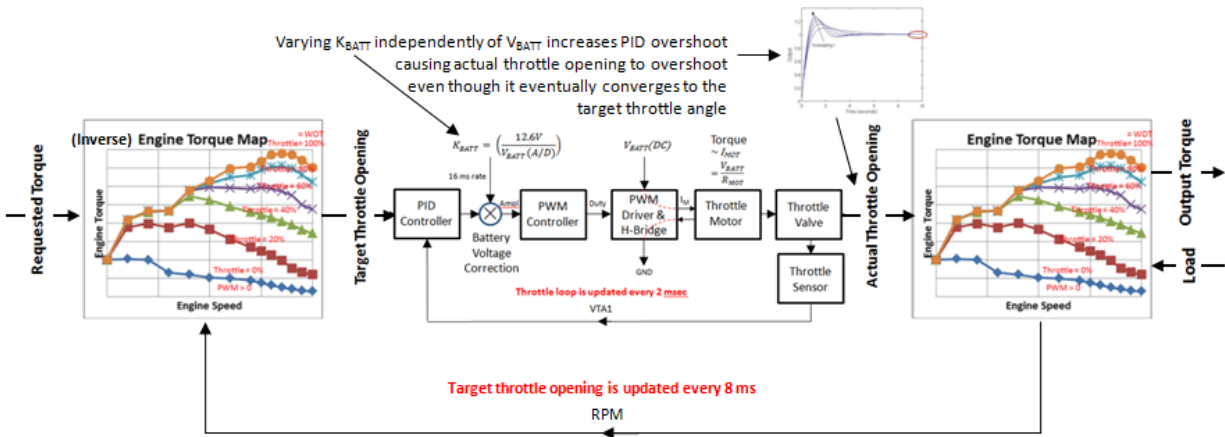
One can simulate the effects of PID overshoot on the RPM feedback loop shown in Figure 2, where the PID overshoot is caused by the incorrect battery voltage compensation of the duty cycle, by substituting maps that correspond to a given engine design. Figure 14 shows the resulting system to be simulated.

Figure 14. The electronic throttle control system can be simulated by substituting maps for a specific engine type. Engine operation is simulated by the engine torque map which is measured using a dynamometer. The inverse engine torque map is really the same engine torque map data, but the data is just read out differently (i.e. it is not an inverse map in a mathematical sense).
