Technical Service BULLETIN

EXCESSIVE SULFUR DIOXIDE ODOR

Models

'02 - '04 Solara (2AZ-FE)

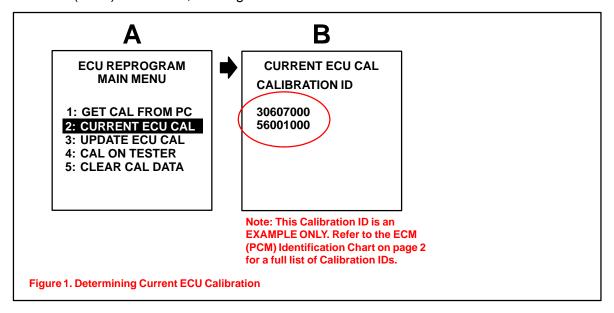
- 1. Check for the Authorized Modification Label affixed to the vehicle in the location shown in Figure 2 on page 4. If there is no label present, proceed to step 2.
- 2. Connect the Diagnostic Tester to the vehicle and select "CURRENT ECU CAL" from the "ECU REPROGRAM MAIN MENU." To determine the vehicle's current ECM (PCM) calibration, see Figure 1 below.

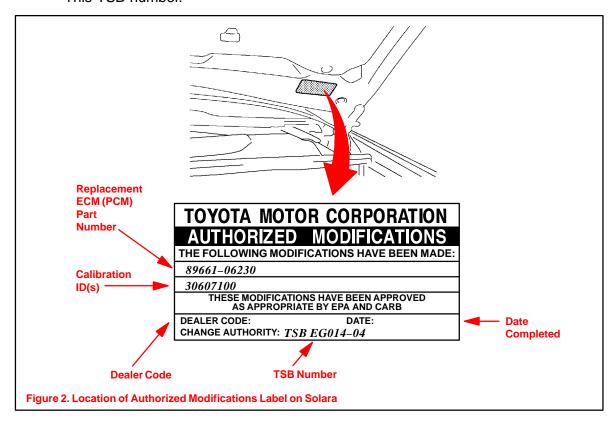
- 6. Test drive vehicle to confirm proper operation and to readjust the ECM (PCM) "Learned Values."
 - Drive the vehicle using light to moderate acceleration in mostly stop and go type driving.
 - Allow the vehicle to shift fully through all gears and at various shifter positions.
- 7. Enter the following information on the Authorized Modification Label shown below in Figure 2 using a permanent marker.
 - ECM (PCM) part number.
 - New ECM (PCM) calibration number.
 - Your dealer code.
 - Reprogramming date.
 - This TSB number.
