**CUSTOMER SATISFACTION NOTIFICATION TO INSTALL A
BRAKE PEDAL SHIFT INTERLOCK**

The satisfaction of our customers is very important to Chrysler. Because of this, we are offering a brake pedal shift interlock to owners of some **1984 through 1995 Jeep Cherokee and Wagoneer; and 1993 through 1995 Grand Cherokee and Grand Wagoneer** vehicles equipped with an automatic transmission and a floor shift.

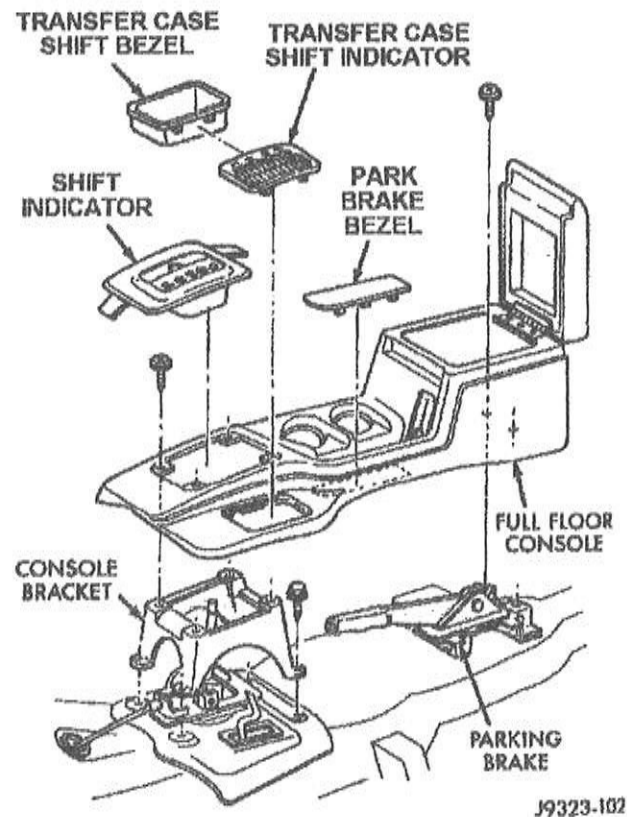
Figure 1

2. Remove the transmission shift lever handle by pulling straight up firmly and quickly.
3. Pry up the transmission shift indicator bezel with a trim stick (Figure 1).
4. Lift the bezel far enough to remove the lamp socket from the bezel and then remove the transmission shift indicator bezel from the console.

5. Pry up the transfer case shift indicator bezel with a trim stick (Figure 1).
6. Lift the bezel far enough to remove the lamp socket from the bezel and then remove the transfer case bezel from the console.
7. Remove the park brake bezel and the console attaching screws and then remove the console (Figure 1).

53. Install the knee blocker and trim panel (Figure 2).
54. Install the console and secure it with the attaching screws (Figure 1).
55. Install the park brake bezel.

56. Install the lamp socket into the transfer case shift bezel and then install the bezel into the console (Figure 1).
57. Install the lamp socket into the transmission shift indicator bezel and then install the bezel into the console (Figure 1).

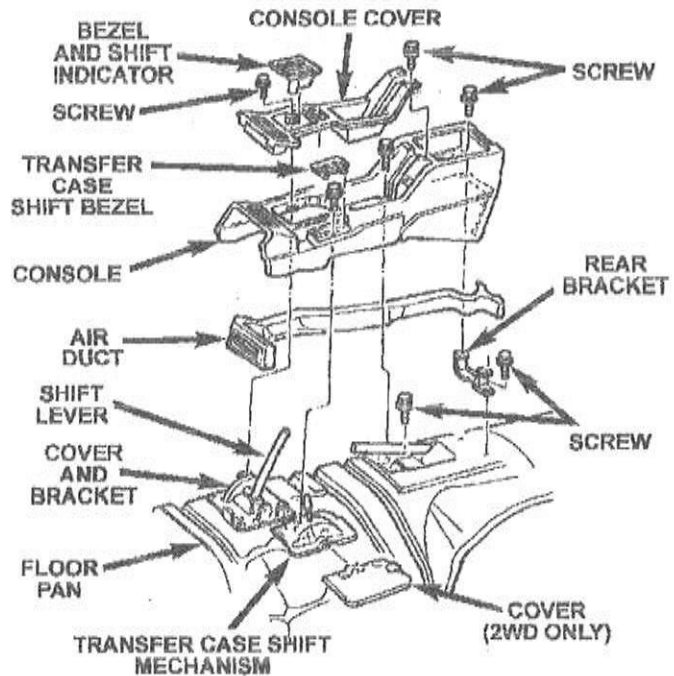
Figure 9

2. Remove the transmission shift lever handle by pulling straight up firmly and quickly.
3. Pry up the transmission shift indicator bezel with a trim stick (Figure 9).

4. Lift the bezel far enough to remove the lamp socket from the bezel and then remove the transmission shift indicator bezel from the console.
5. Pry up the transfer case shift indicator bezel with a trim stick (if equipped) (Figure 9).
6. Lift the bezel far enough to remove the lamp socket from the bezel and then remove the transfer case bezel from the console (if equipped).
7. Remove the power outside mirror switch (if equipped).
8. **For vehicles with a full console:** Remove the console cover attaching screws and then remove the console cover (Figure 9).
9. Remove the console attaching screws and then remove the console (Figure 9).
10. Remove the console air duct (if equipped) (Figure 9).

45. Install the console air duct and then install the console and secure it with the attaching screws (Figure 9).
46. Install the console cover (if equipped) and secure it with the attaching screws (Figure 9) and then install the power mirror switch (if equipped).

47. Install the lamp socket into the transfer case shift bezel and then install the bezel into the console (if equipped) (Figure 9).
48. Install the lamp socket into the transmission shift indicator bezel and then install the bezel into the console (Figure 9).

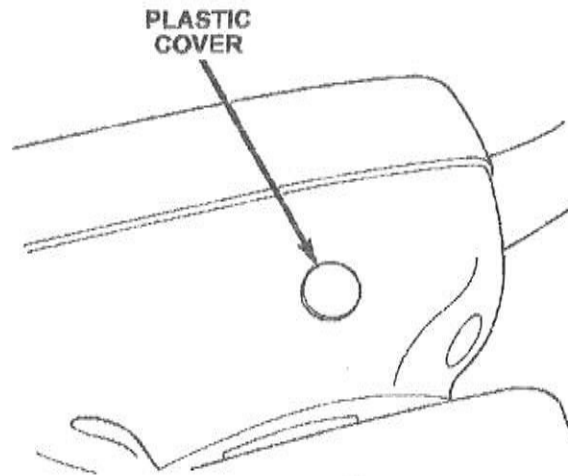
Figure 10

- Using a small screwdriver, remove the plastic cover plug from the top outer surface of the steering wheel hub (Figure 10). Exit the vehicle.

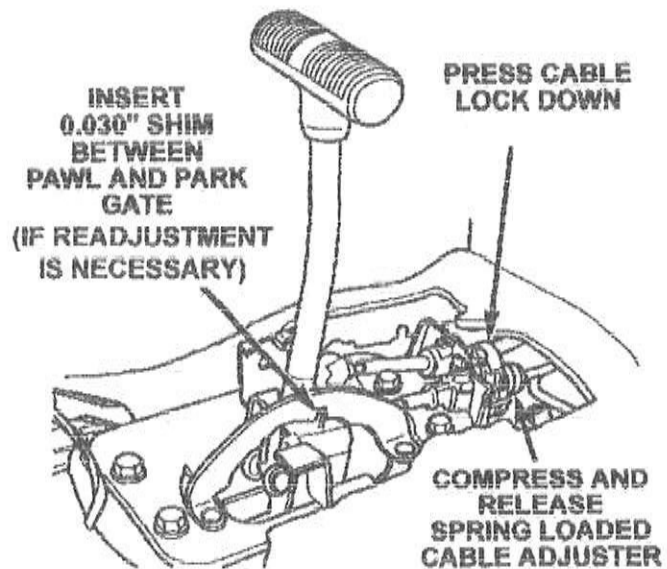
Figure 17

28. Turn the ignition key to the ACC (accessory) position.
29. Ensure that the floor shifter is in the PARK position.
30. Remove the shipping pin from the cable ignition key lock cylinder fitting (Figure 15).
31. Compress and release the spring loaded cable adjuster (Figure 17).
32. Press the interlock cable lock clamp down until it snaps into place (Figure 17).

- C. Compress and release the spring loaded cable adjuster (Figure 17).
NOTE: If a second cable adjustment is required, insert a .030 pin or shim between the pawl and the park gate (Figure 17) and continue the adjustment procedure. Remove the pin or shim after the cable has been locked.

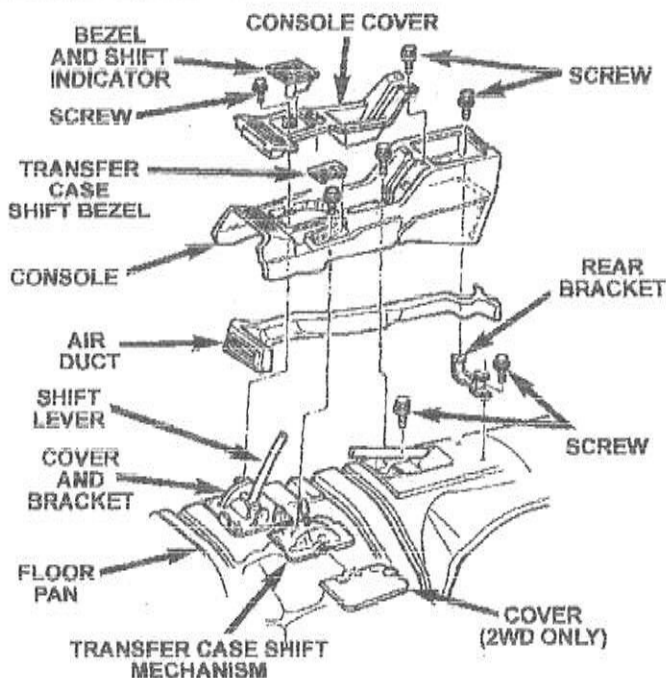
Figure 19

1. Remove the transmission shift lever handle by pulling straight up firmly and quickly.
2. Pry up the transmission shift indicator bezel with a trim stick (Figure 19).

3. Lift the bezel far enough to remove the lamp socket from the bezel and then remove the transmission shift indicator bezel from the console.
4. Pry up the transfer case shift indicator bezel with a trim stick (if equipped) (Figure 19).

7. **For vehicles with a full console:** Remove the console cover attaching screws and then remove the console cover (Figure 19).
8. Remove the console attaching screws and then remove the console (Figure 19).

9. Remove the console air duct (if equipped) (Figure 19).
10. Remove the lower instrument panel trim panel (Figure 20).

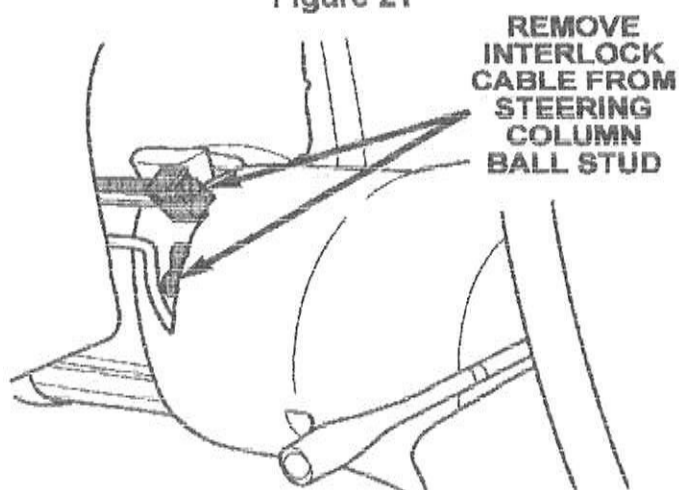
Figure 22

13. Disconnect the ignition interlock cable from the steering column ball stud (Figure 22).

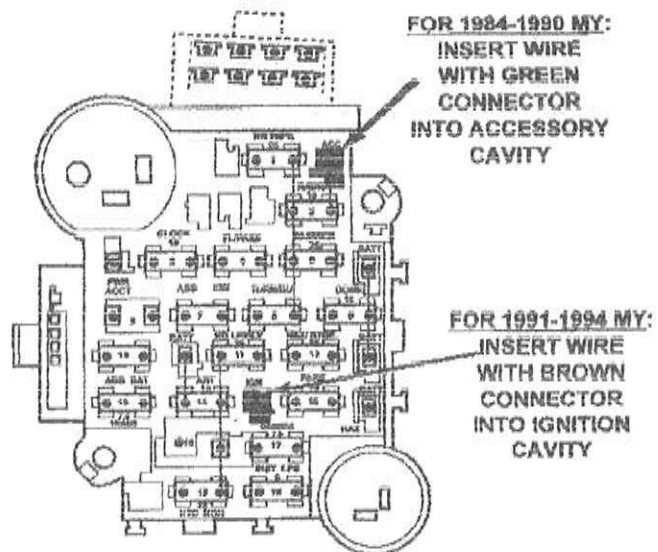
Figure 26

- **FOR 1991 - 1994 MODEL YEAR VEHICLES:** Insert the **BROWN** wiring harness single wire connector into the fuse block **IGNITION FEED** location marked "IGN" (Figure 26).
- **FOR 1984 - 1990 MODEL YEAR VEHICLES:** Insert the **GREEN** wiring harness single wire connector to the fuse block **ACCESSORY FEED** location marked "ACC" (Figure 26).

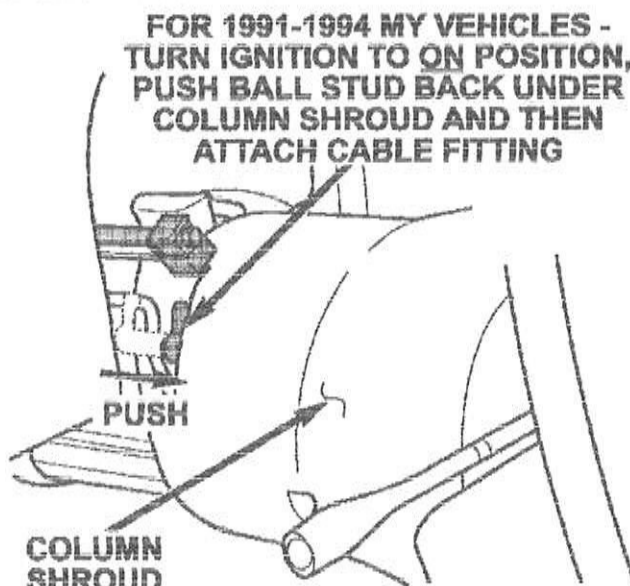
Figure 27

28. Connect the cable to the ball stud on the steering column as follows (Figure 27):

- **For 1991-1994 model year vehicles:** Turn the ignition key to the ON position to energize the solenoid and extend the ball stud rod. Push the ball stud rod back up under the steering column shroud and then attach the cable fitting to the ball stud while holding the stud in position. Make sure the ball stud is bottomed out.

- **For 1984-1990 model year vehicles:** Turn the ignition key to the ACCESSORY position. Connect the cable fitting to the ball stud. Make sure the ball stud is bottomed out.

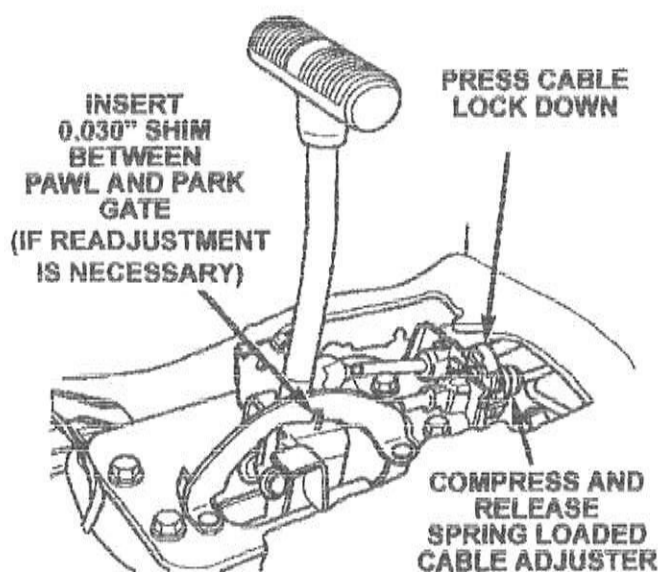
Figure 28

35. Compress and release the spring loaded cable adjuster (Figure 28).

36. Press the interlock cable lock clamp down until it snaps into place (Figure 28).
37. Install the floor shifter handle.
38. Verify that the shift interlock operates properly:

- A. Shift the transmission into PARK and turn the ignition key to the ON position.
- B. Pull up the cable lock button to release the cable.
- C. Compress and release the spring loaded cable adjuster (Figure 28).

NOTE: If a second cable adjustment is required, insert a .030 pin or shim between the pawl and the park gate (Figure 28) and continue the adjustment procedure. Remove the pin or shim after the cable has been locked.
