**Technical Service
BULLETIN**

EXCESSIVE SULFUR DIOXIDE ODOR

'02 – '04 Camry (2AZ-FE)

ENGINE
EG013-04

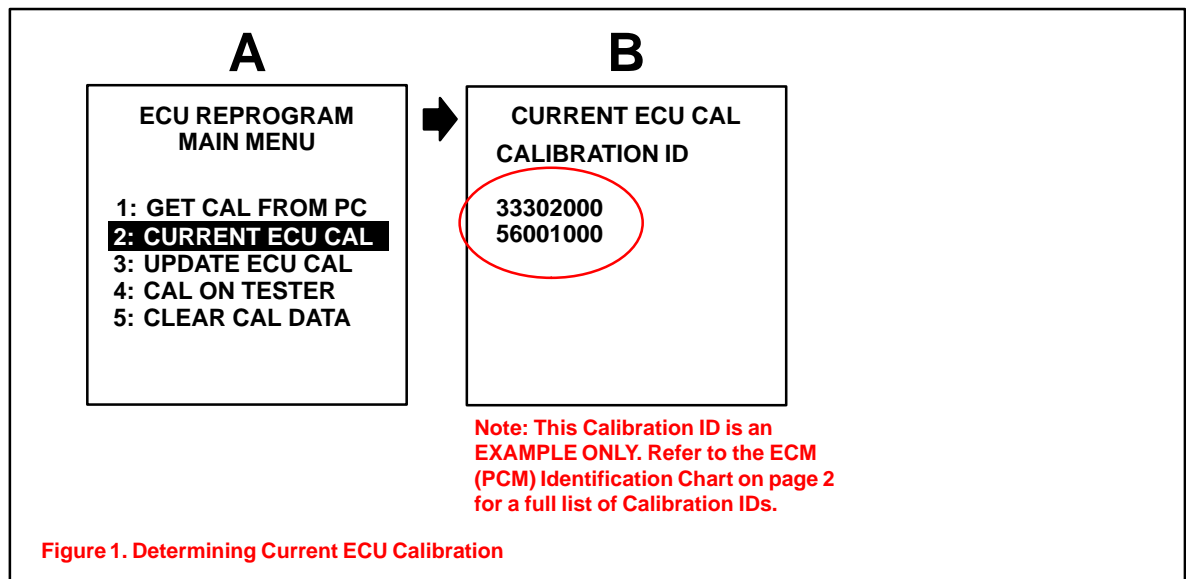
1. Check for the Authorized Modification Label affixed to the vehicle in the location shown in Figure 2 on page 4. If there is no label present, proceed to step 2.
2. Connect the Diagnostic Tester to the vehicle and select “CURRENT ECU CAL” from the “ECU REPROGRAM MAIN MENU.” To determine the vehicle’s current ECM (PCM) calibration, see Figure 1 below.
