**Technical Service  
BULLETIN**

**EXCESSIVE SULFUR DIOXIDE ODOR**

'03 – '04 4Runner (1GR-FE)

**ENGINE**  
**EG015-04**

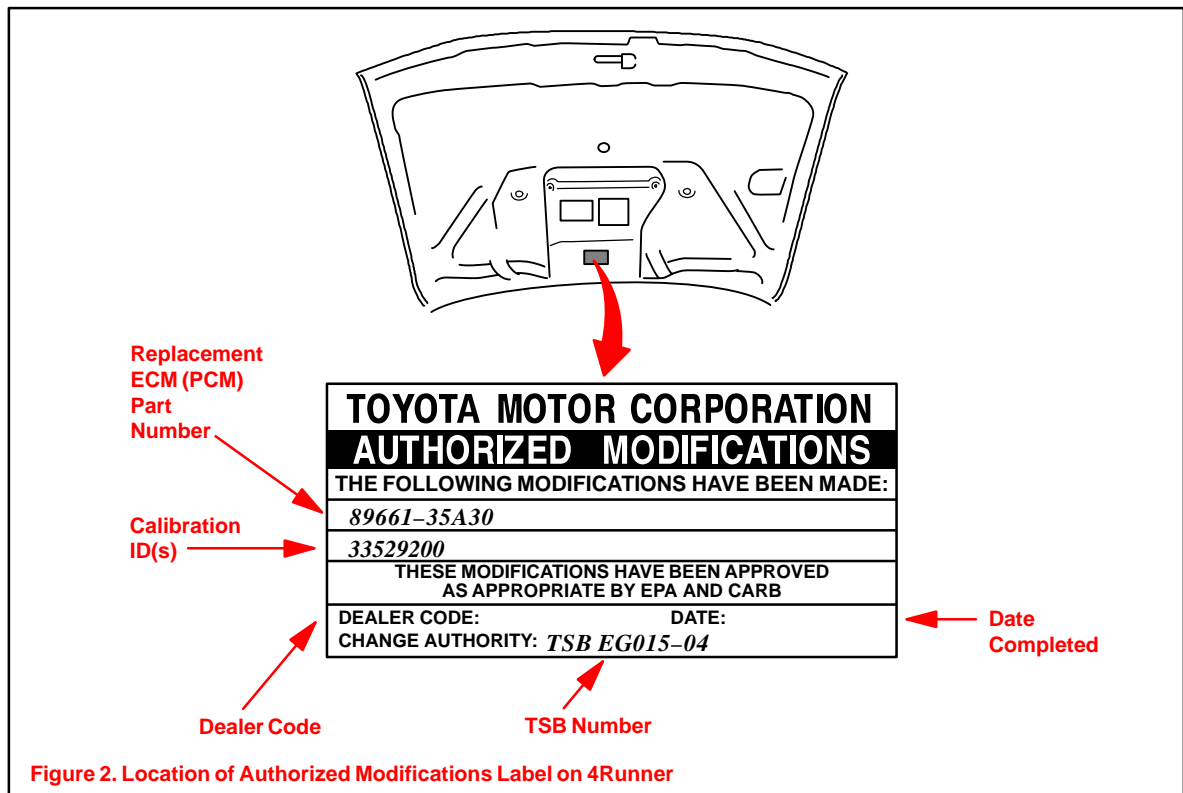
6. Start the engine and warm up the vehicle to normal operating temperatures before test-driving.
7. Test drive vehicle to confirm proper operation and to readjust the ECM (PCM) "Learned Values."
  - Drive the vehicle using light to moderate acceleration in mostly stop and go type driving.
  - Allow the vehicle to shift fully through all gears and at various shifter positions (D, 3, 2, L).
8. Enter the following information on the Authorized Modification Label shown below in Figure 2 using a permanent marker.
  - ECM (PCM) part number.
  - New ECM (PCM) calibration number.
  - Your dealer code.
  - Reprogramming date.
  - This TSB number.

1. Check for the Authorized Modification Label affixed to the vehicle in the location shown in Figure 2 on page 4. If there is no label present, proceed to step 2.
2. Connect the Diagnostic Tester to the vehicle and select “CURRENT ECU CAL” from the “ECU REPROGRAM MAIN MENU.” To determine the vehicle’s current ECM (PCM) calibration, see Figure 1 shown below.
