## **Ford Motor Company Crown Victoria Police Interceptors Summary**

# 1. No design can eliminate all risk in high-speed, high-impact rear collisions that result in fires – each accident is unique. And these accidents are very rare among the many risks officers face in their daily jobs.

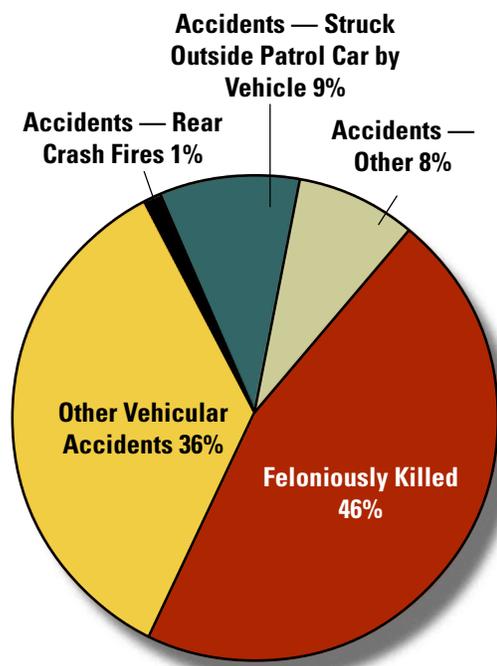
**Cause of Officer Fatalities  
1996-2000**

Source: FBI; Reported CBPI incidents

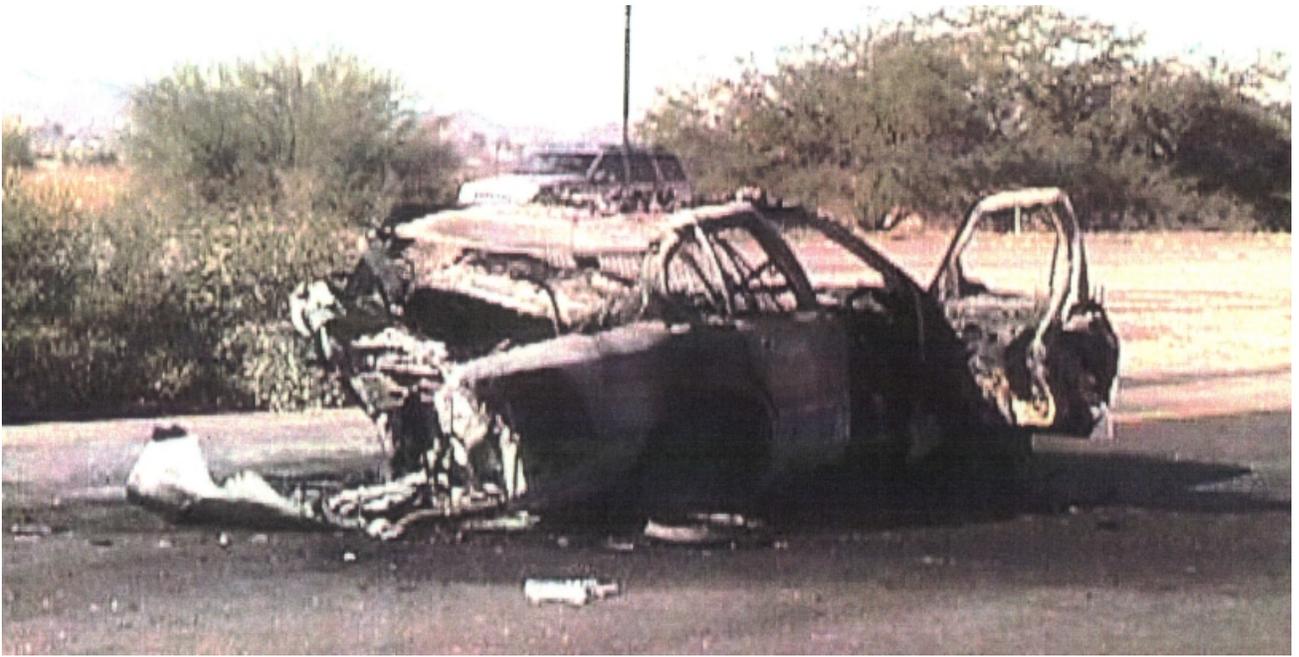
*Officer Juan Cruz's CVPI*

- At about 2:20 a.m. Dec. 9, 1998, Officer Juan Cruz was sitting in his Crown Victoria Police Interceptor, which was being used as a “safety blocker” at an accident scene involving a vehicle fire when it was struck by a car driven by a drunk driver going 72 mph. Emergency lights from the accident scene were clearly visible from more than a mile away, and there were safety cones marking traffic lanes. The car slammed into Officer Cruz’s vehicle, essentially pushing the entire rear end into the front seat. A parking brake cable bolt punctured the fuel tank. The drunken driver was sentenced to 11 years in prison.

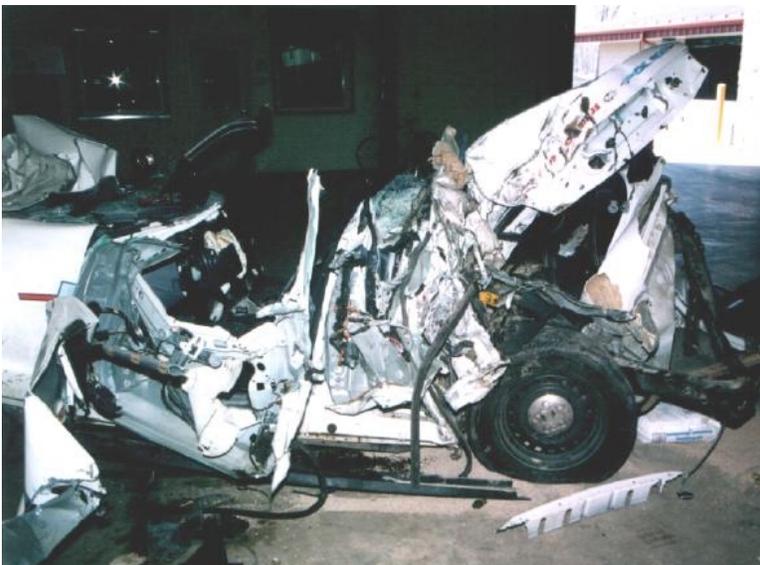
*Officer Daniel Czajkowski's CVPI*

- On April 3, 2002, Romulus (Mich.) Police Officer Daniel Czajkowski had stopped a semi/tractor-trailer for speeding. His CVPI was parked partially in the travel lane when it was slammed from behind by another tractor-trailer traveling at about 65 mph. The force of the impact compressed the entire left side of the car into a one-foot space behind the driver. Although the semi/tractor-trailer dumped its entire fuel load, the CVPI's tank remained intact.

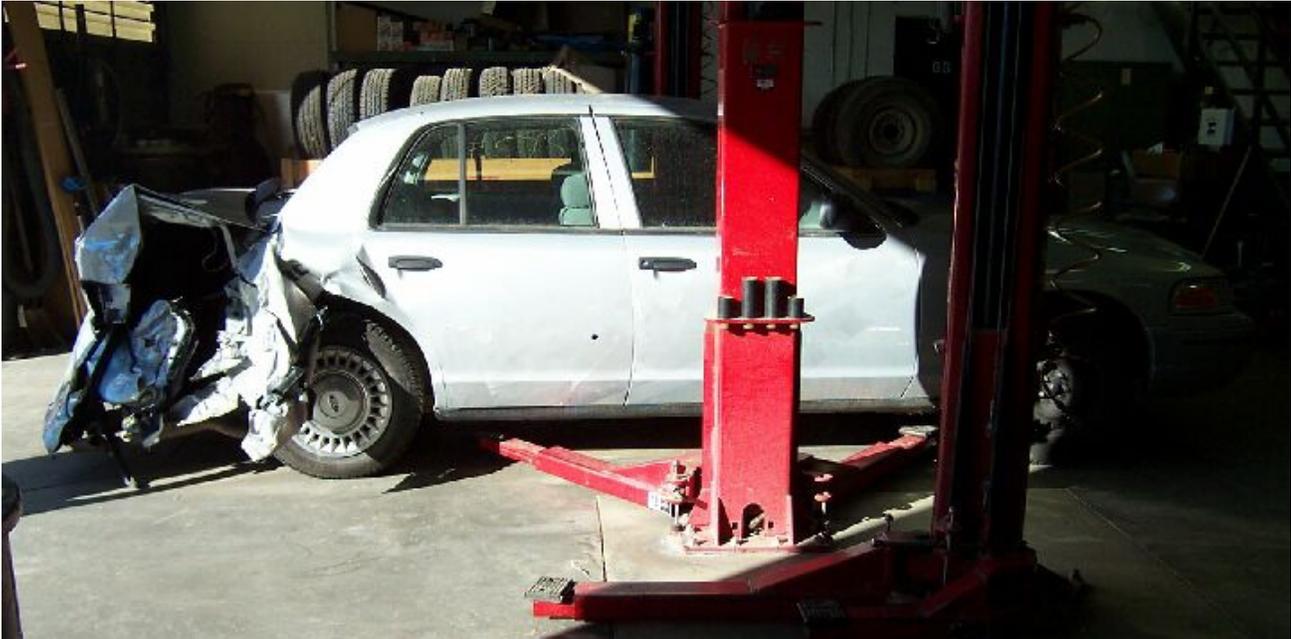
*Colorado — December 8, 2001*

## Examples of High-Speed, Rear-End Crown Victoria Accidents Where There Were No Fuel Leaks or Fires

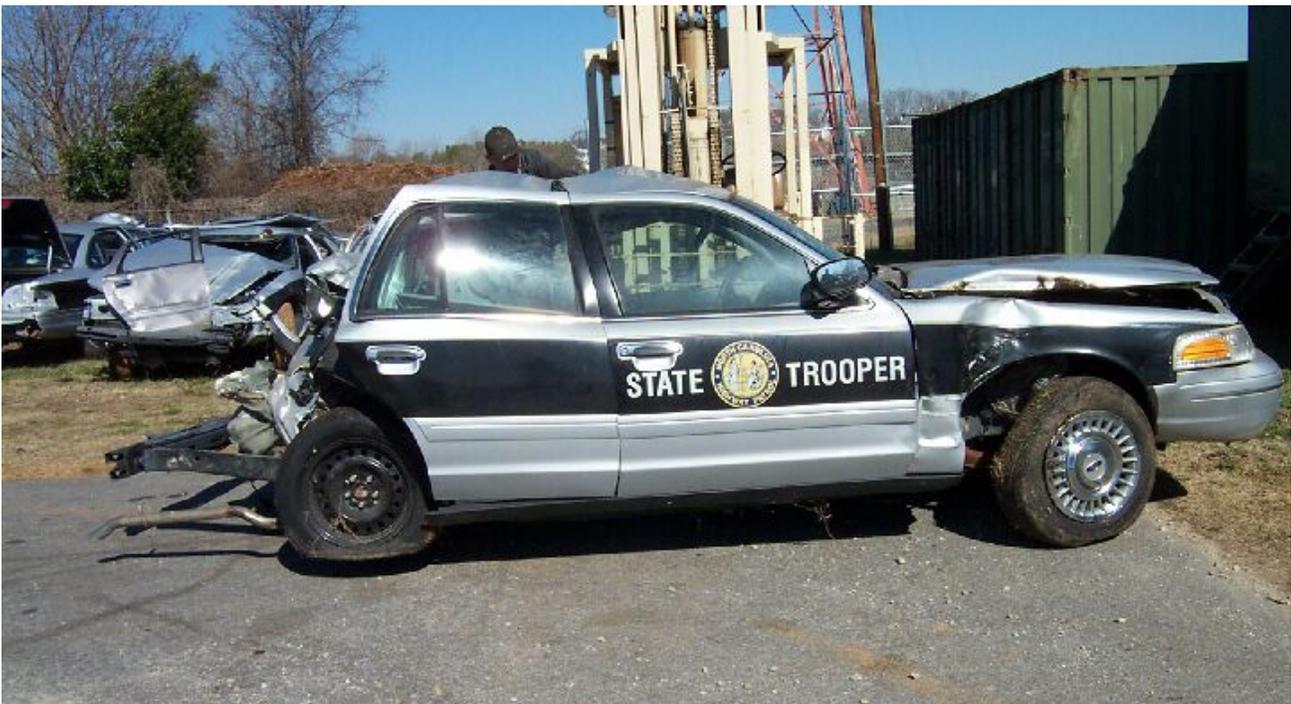
*North Carolina — October 23, 1999*

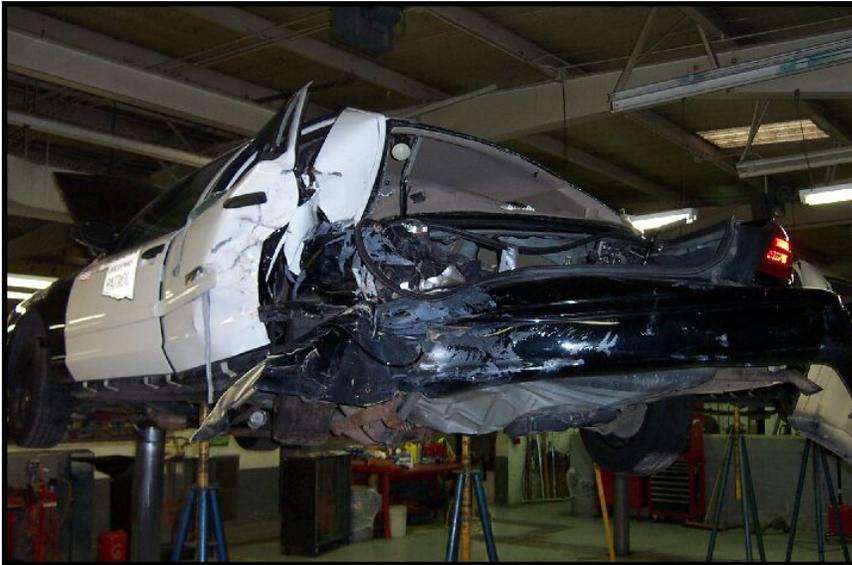
*Top: Oklahoma — November 3, 2001*

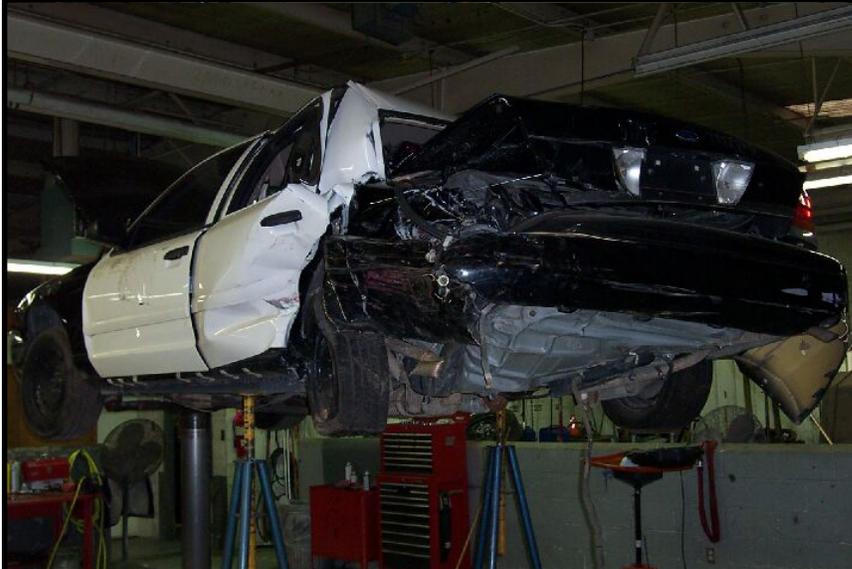
*Center: Oklahoma — May 21, 2001*

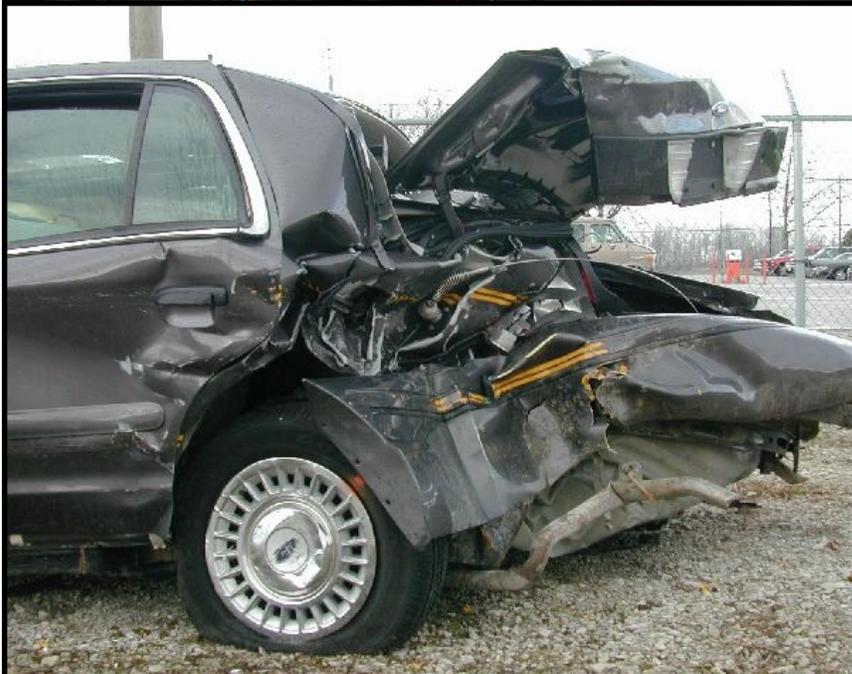
*Bottom: Ohio — March 28, 2002*

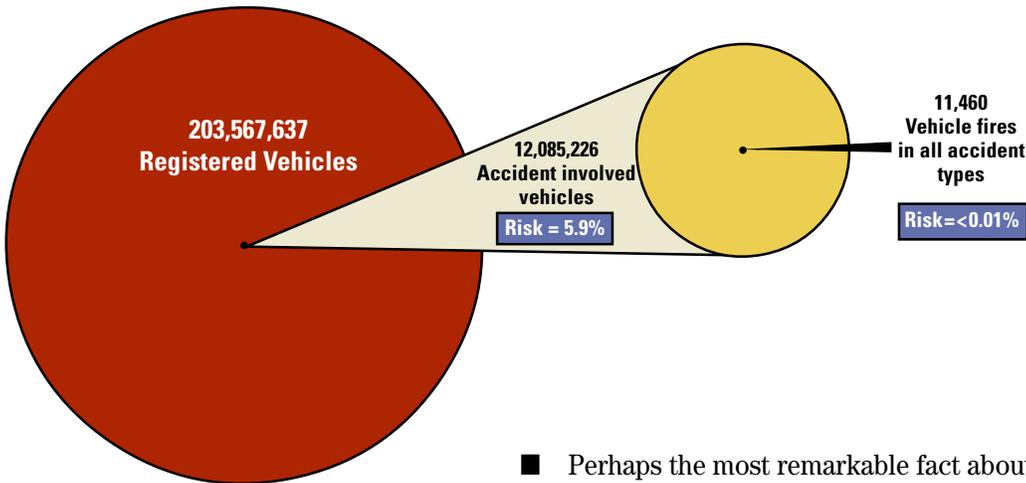
Source: GES (1997); Traffic Safety Facts, 1997, NHTSA

### Fire Accident Frequency 1997

- Accident data show that the number of rear-collision fires involving the CVPI is comparable with other makes and models, including those with same or alternative fuel tank locations.

- A direct comparison of the CVPI and the Ford Taurus, which has a different fuel tank placement and also is used in police work, showed comparable fire rates. The CVPI has an incident rate of 1 fire out of 1,000 rear-end collisions, while the Ford Taurus has 1.1 out of 1,000 collisions.

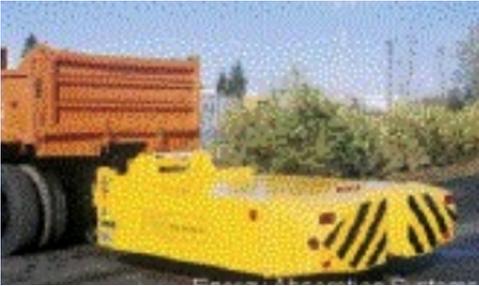
*A truck with “blocker” attached to protect construction vehicles; such blockers, although designed for a single purpose, are certified only for collisions up to 62 mph.*

- Mandate drivers vacate the lane adjacent to a stopped police car in multi-lane highways.
  - Consider special, heavy-duty “blocker” equipment to protect construction workers. Some states require police to remove their cars from these dangerous “blocking” situations as soon as the emergency is over. Note: “Blocker” trucks are only certified to 62 mph.
