SUMMARY REPORT:
CENTRE MOUNTED TANK SYSTEM
FOR GM 1500 PICKUP TRUCKS

Prepared for: Dr. Ken Digges
Automotive Safety
Research Institute

Date: March 8, 2001

Report No.: R01-02

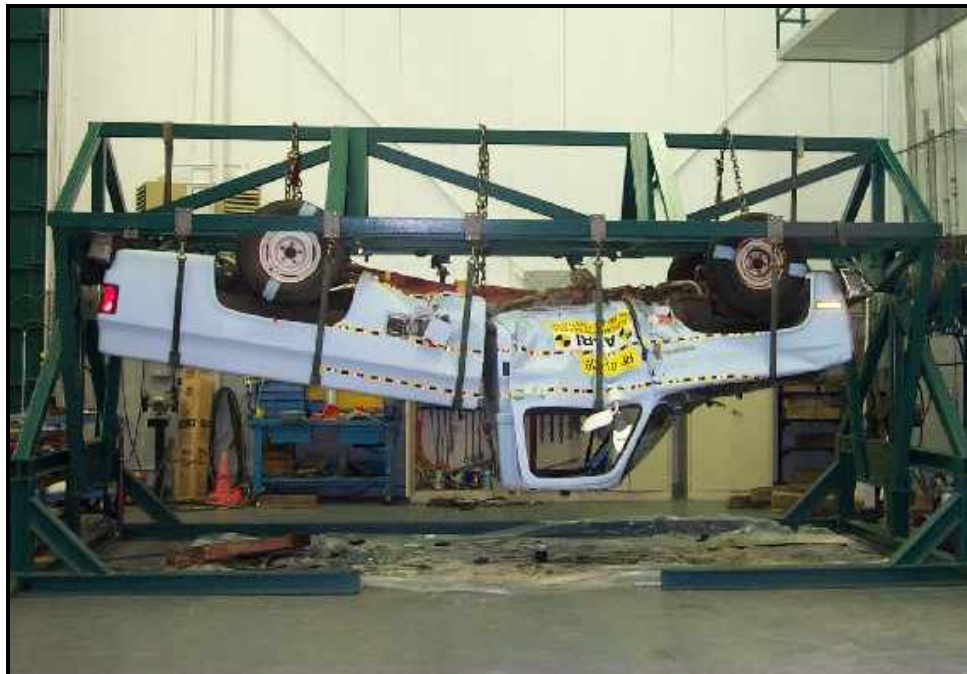
Following the impact there was a minimal amount of fluid spillage, which was well within the requirements of FMVSS 301. However, to further confirm the integrity of the tank, the truck was inverted as per FMVSS 301 (see Figure 20).

Figure 20: Inversion of the truck following the impact (test RP 01-009).

The inversion test confirmed that fuel tank system installed in this truck met all of the fuel leakage requirements specified in FMVSS 301.

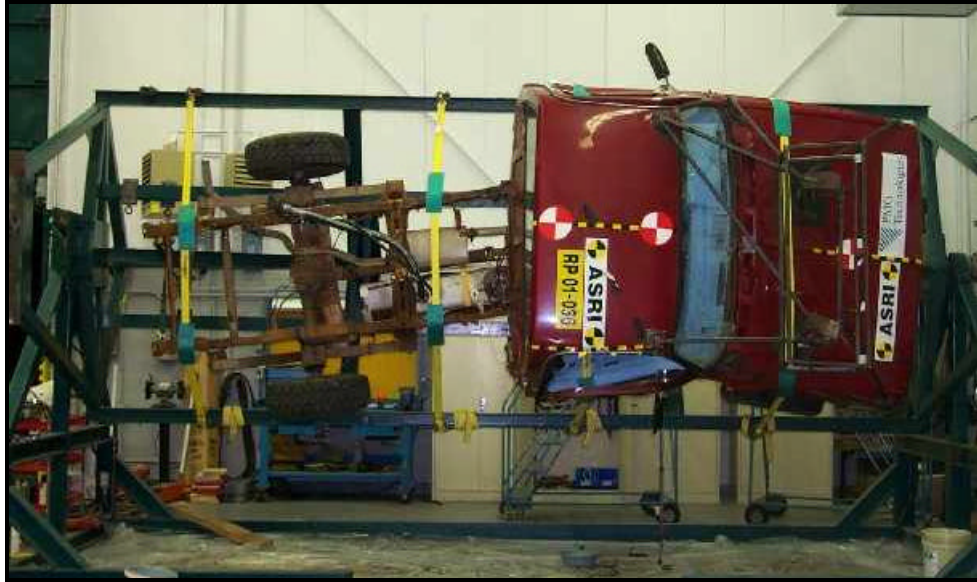
Although technically this test would have failed the requirements of FMVSS 301 it is worthy to note that had only the centre tank been installed and thus a switching would not have been required, the tank would have passed the test. With this in mind the fuel lines were plugged and the tank was refilled with fluid

Figure 31: Rollover test to confirm centre tank integrity (test RP 01-036).

There was no leaking observed during the rollover test confirming that the integrity of the centre mounted tank remained intact.

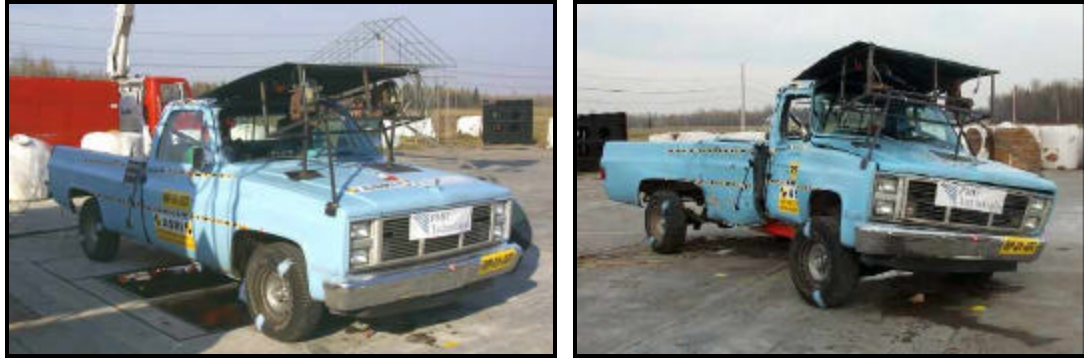
Figure 34: Pre and post test views of the pickup truck (test RP 01-037).

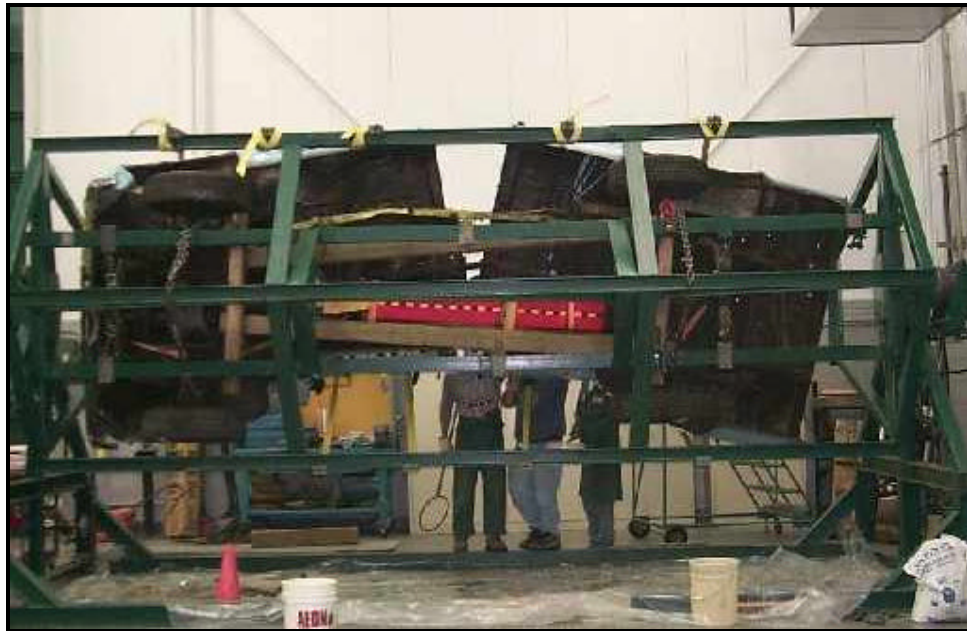
Following the test no fluid leakage from the centre tank was observed with the exception of a small leak in the box tank that was within acceptable limits.. Further confirmation of the centre tank system's integrity was obtained by subjecting the truck to a rollover test, as shown in Figure 35.

Figure 35: Inversion of the truck following the impact (test RP 01-037).

The rollover test confirmed that there were no leaks in the centre mounted tank.

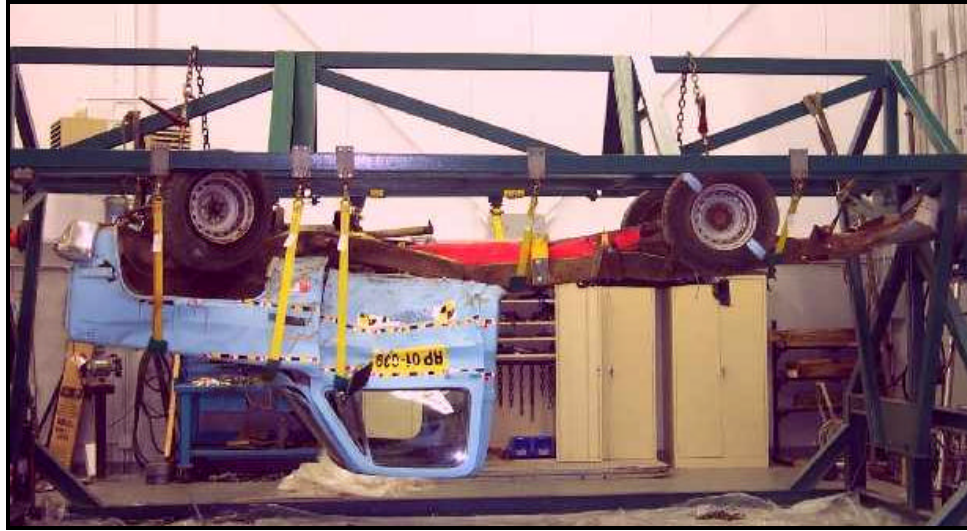
During the collision, there was an initial spray of fluids, which could not be measured. It is believed that the fluids were forced out from the connection of the filler vent line and the filler cap assembly due to the overpressure in the fuel tank. After the event was over there was no indication of continued fluid leakage. An inversion test on the truck revealed a small amount of leaking from the carburettor but not from the tank components, thus confirming the integrity of the tank system as no additional leakage was observed (see Figure 54).

Figure 54: Inversion test of truck 9 (test RP 01-039).

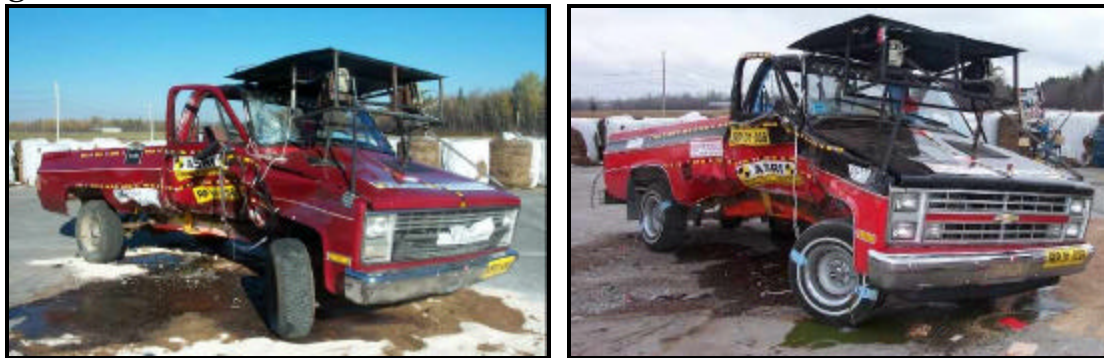
The speed of the collision in test RP 01-037 was 40.1 mph by a FMVSS 301 rigid moving barrier and therefore the truck accelerations from that test can not be compared to the other two tests. However, tests RP 01-036 and RP 01-038 appear to be similar. Their collision speeds were the same and their deformation patterns were similar although the truck from test RP 01-038 appears to be bent upwards slightly more than the truck in test RP 01-036 (see Figure 60 and Figure 61).

Figure 60: Crush patterns in test RP 01-036 (left) and RP 01-038 (right) – view 1.

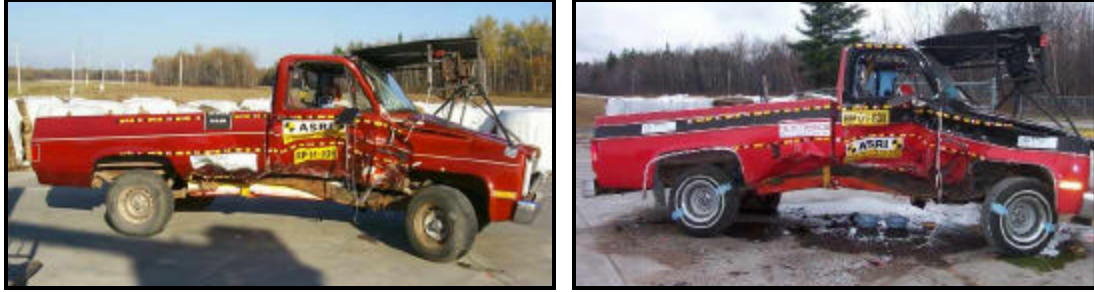
Figure 61: Crush patterns in test RP 01-036 (left) and RP 01-038 (right) – view 2.

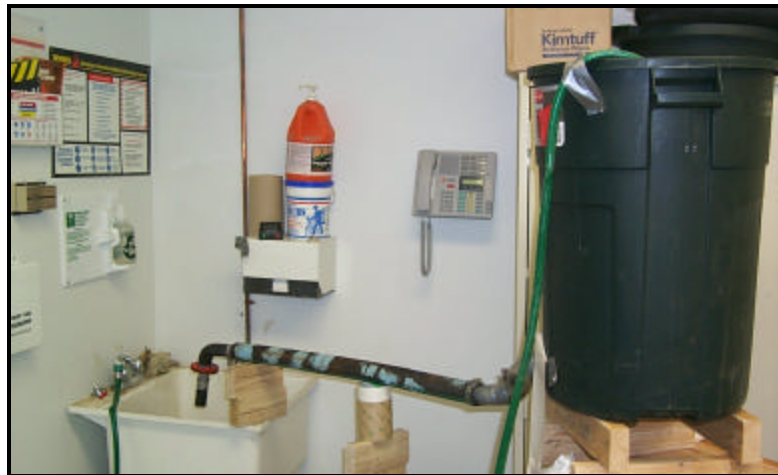
The complete fuel supply system comprised of the filler throat, the horizontal supply hose, the reducer/elbow and the check valve (see Figure 66). A detailed shot of the check valve and the reducer/elbow can be seen in Figure 67. A view of the water draining through the check valve is shown in Figure 68. The time required to drain the container was measured to be 85 seconds.

Figure 66: Horizontal filler tube with reducer elbow and check valve.

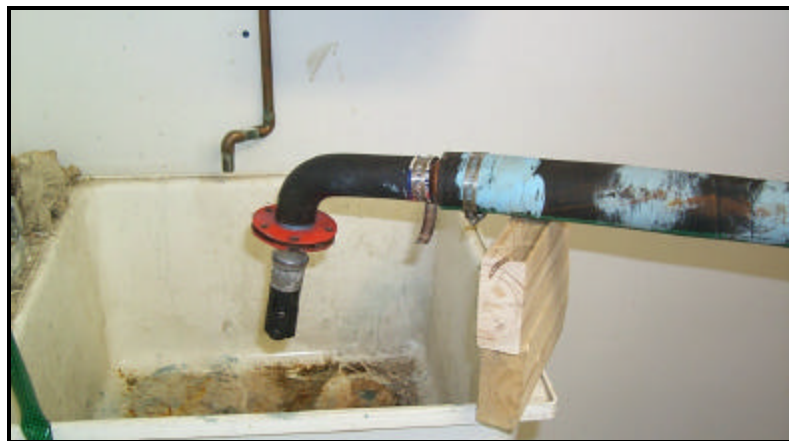
Figure 67: Close-up of the reducer elbow and the check valve

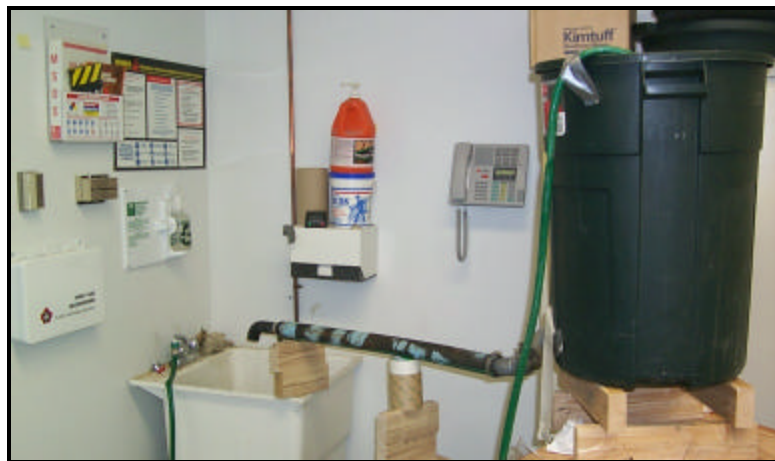
This system is identical to the one above with the exception that there is no check valve at the end of the supply system (see Figure 69). A close-up view of the reducer/elbow without the check valve can be seen in Figure 70. The time required to drain the container was measured to be 53 seconds.

Figure 69: Horizontal filler tube with reducer elbow (NO check valve).

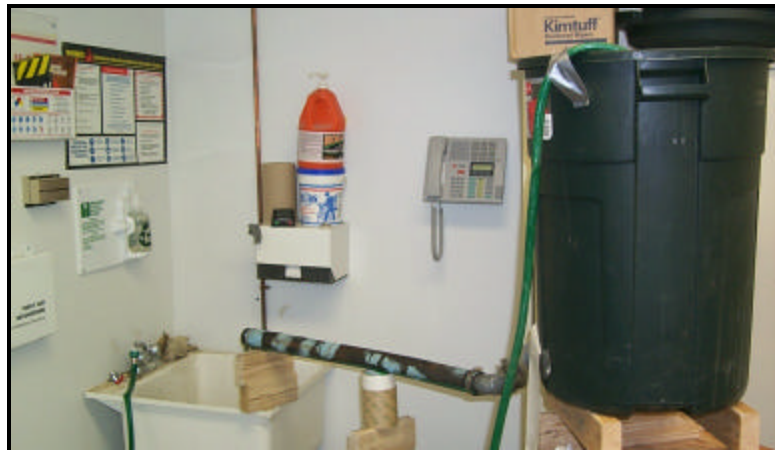
This system is identical to the one above with the exception that there is no check valve or reducer/elbow at the end of the supply system (see Figure 71). A close-up view of the filler tube without the reducer elbow or the check valve is shown in Figure 72. The time required to drain the container was measured to be 38 seconds.

Figure 71: Fuel supply tube without reducer elbow or check valve.

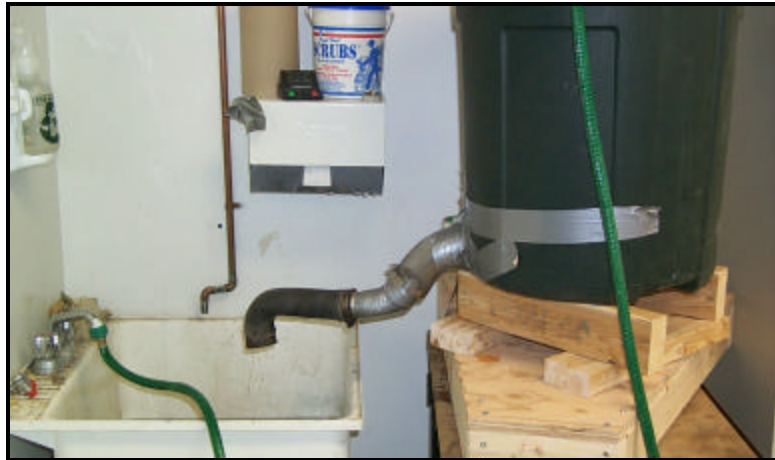
This system consists of a supply system that would be found on a GM pickup truck with a standard fuel tank (see Figure 73). The time required to drain the container was measured to be 38 seconds.

Figure 73: Standard GM pickup truck fuel filler tube.
